Storm Drain Modeling Data & CCTV Storm
Drain Condition Assessment Memorandum

Date: July 7, 2020
From: Joey Hegna, P.E. – CRW Engineering Group, LLC
Project: Lois Drive and 32nd Avenue Pathway – Benson Boulevard to Minnesota Drive
Project No: PM&E# 19-08 (CRW# 10145.00)
Subject: Storm Drain Condition Assessment (DRAFT)

Lois Drive and 32nd Avenue Pathway – Benson Boulevard to Minnesota Drive
Storm Drain Condition Assessment (DRAFT)

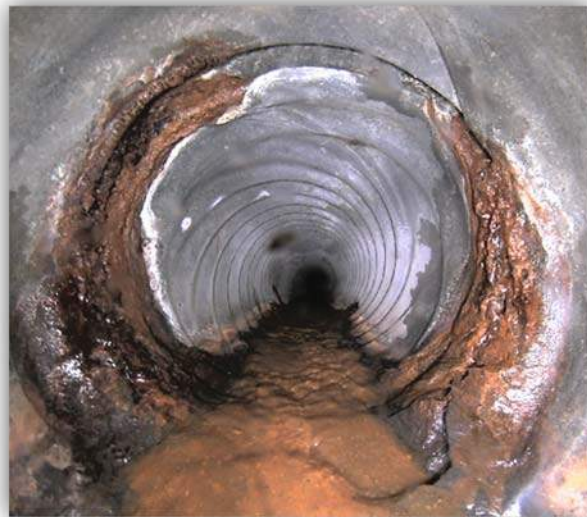
Photo 1 - Mineralization/Infiltration at Joint

The majority of the inspected pipes have significant debris (rocks, soil, mineralization, etc.) deposited within the pipe. These blockages reduce the overall capacity of the piping system and can further deteriorate the condition of the pipe. The *Storm Drain CCTV Inspection Summary Table, Appendix B* recommends several pipes to be cleaned to improve flow efficiency and extend the life of the piped system. While cleaning these pipes is recommended and good practice, it won't necessarily resolve the source of the debris entering into the pipe (joint offsets & holes). This is where lining, also known as cured in place pipe (CIPP), may be an option to repair these pipes and reduce the amount of debris entering the system. CIPP is a trenchless method (no excavation required) for rehabilitating existing pipe. CIPP consists of a liner that is constructed of a soft fabric tube that is impregnated with resin. After the tube is inserted into the

existing (host) pipe, it is inflated with water or air and cured until hard. A CIPP liner provides a long-term fully structural repair to the host pipe. Further investigation would be required to determine if CIPP is a suitable repair option the identified pipes. The alternative is to remove and replace these pipes by conventional open cut excavation methods.

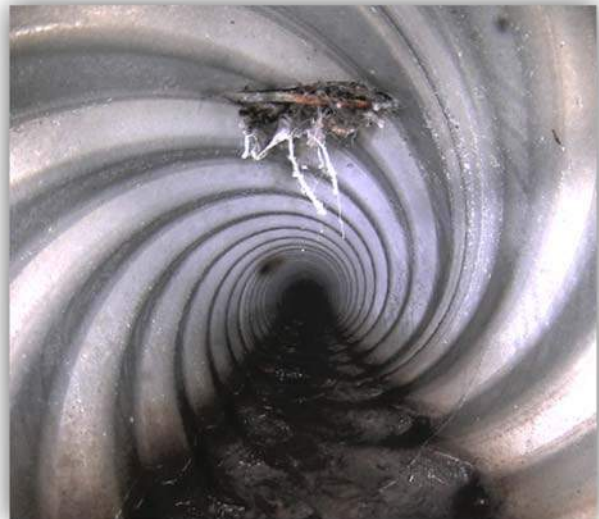
- Pipe 27764: Mineralization/infiltration and root intrusion at several locations along this pipe segment, as well as a significant gouge in the pipe.
- Pipe 30570: Significant pipe joint separation.

Photo 2 - Pipe Gouge

Several storm drain pipes (12828, 13603, 25204, 27764, 27885, 30570, & 33747) are identified as requiring complete replacement or CIPP lining. These pipes or certain segments of the pipe have significant enough defects where cleaning alone is not a suitable long-term fix.

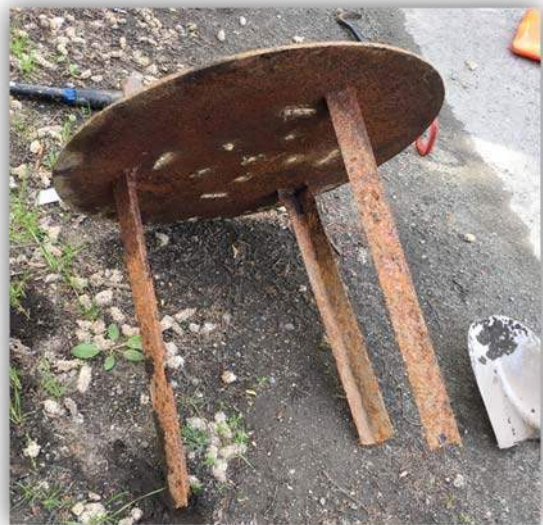
Photo 4 - Non-standard Manhole Lid

- Catch Basin Manhole 82: Non-standard frame, offset between barrel and reducing slab, and sump and outlet pipe (east) full of debris/sediment.
- Manhole 44: Angle iron welded to non-standard lid that rests directly on reducing cone.
- Manhole 45: Manhole lid partially located under pavement, preventing access to structure for maintenance.
- Manhole 97: Spalling at grade ring constructed of brick, non-standard ladder rungs exceeding maximum spacing, non-standard frame & lid, and grout cracking at pipe penetration (west).
- Manhole 120: Manhole lid buried in gravel (difficult to locate), vertical cracking in grade ring, and grade ring offset from reducing cone & frame.

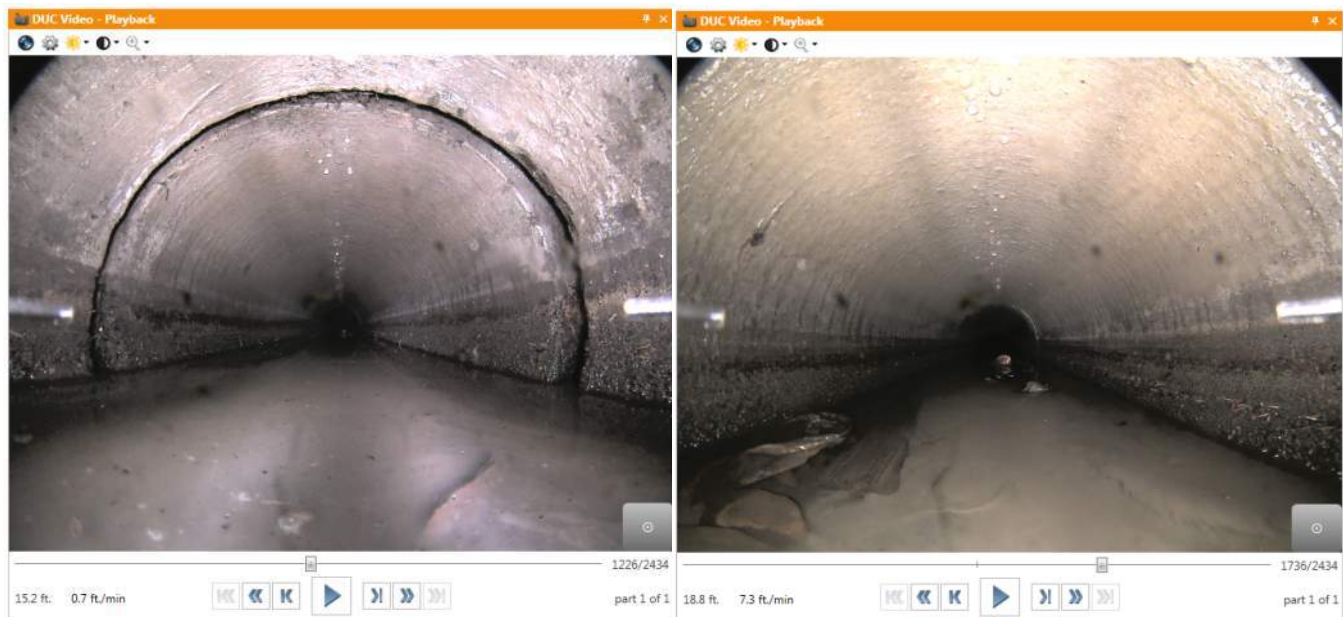
Lois Drive and 32nd Avenue Pathway MOA Pipe #12828 - W. 32nd Ave (west of Minnesota Dr)

Miscellaneous/Defect Notes: Offset joints at 15.5 feet & 21.8 feet. Pipe exceeds 300 foot max. manhole spacing per MASS.

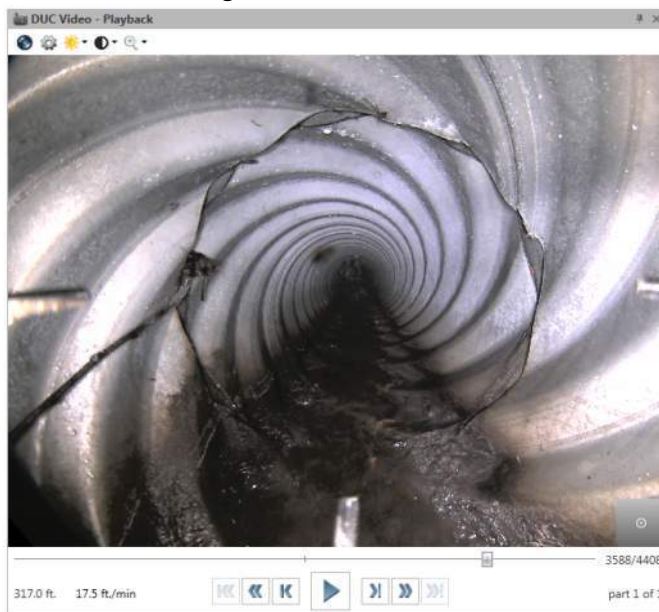
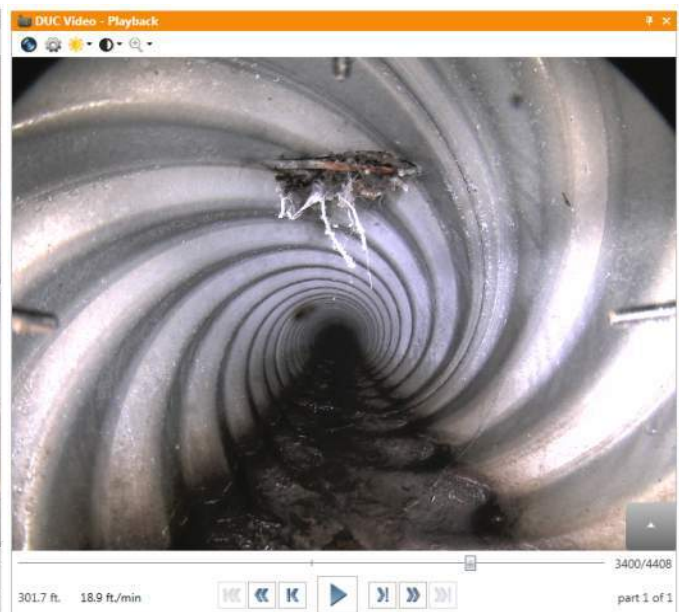
Lois Drive and 32nd Avenue Pathway MOA Pipe #27764 - Lois Dr (north of W. 31st Ave)

Miscellaneous/Defect Notes: Mineralization/infiltration at pipe joints at 132.1 feet, 197.3 feet & 216.6 feet. Root intrusion at pipe joints at 216.6 feet & 317.0 feet. 1"x4" gouge through pipe at 12 o'clock position at 301.7 feet, soil visible.

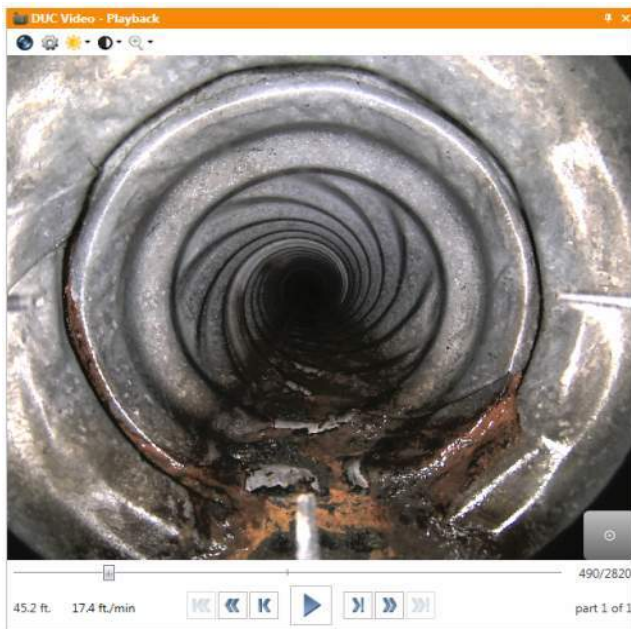
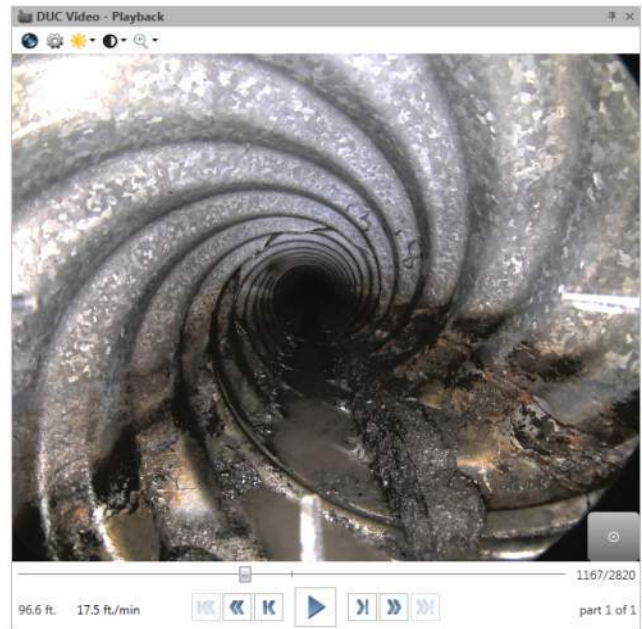
Lois Drive and 32nd Avenue Pathway MOA Pipe #29551 - Lois Dr (south of W. 31st Ave)

Miscellaneous/Defect Notes: Mineralization/Infiltration at pipe joint at 45.3 feet and 65.4 feet.

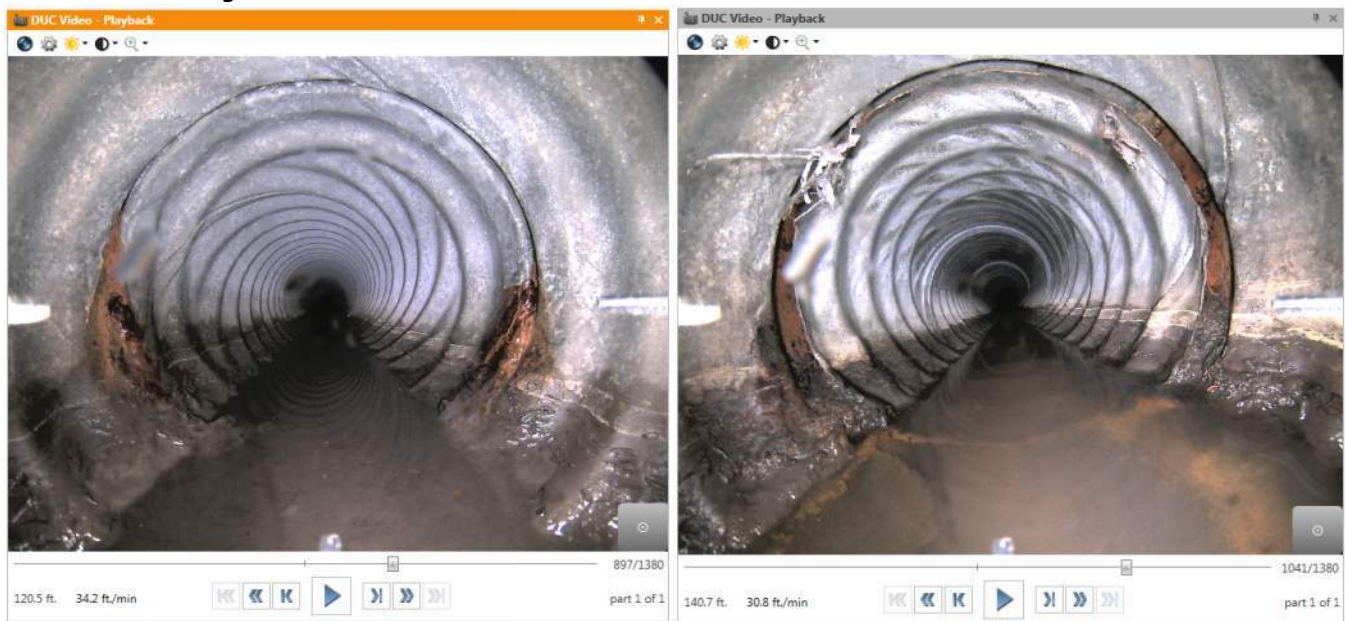
Lois Drive and 32nd Avenue Pathway MOA Pipe #25204 - W. 31st Ave (west of Lois Dr)

Miscellaneous/Defect Notes: Mineralization/infiltration at pipe joints at 39.6 feet, 59.9 feet, 120.6 feet & 161.0 feet. Significant joint separation at 140.7 feet.

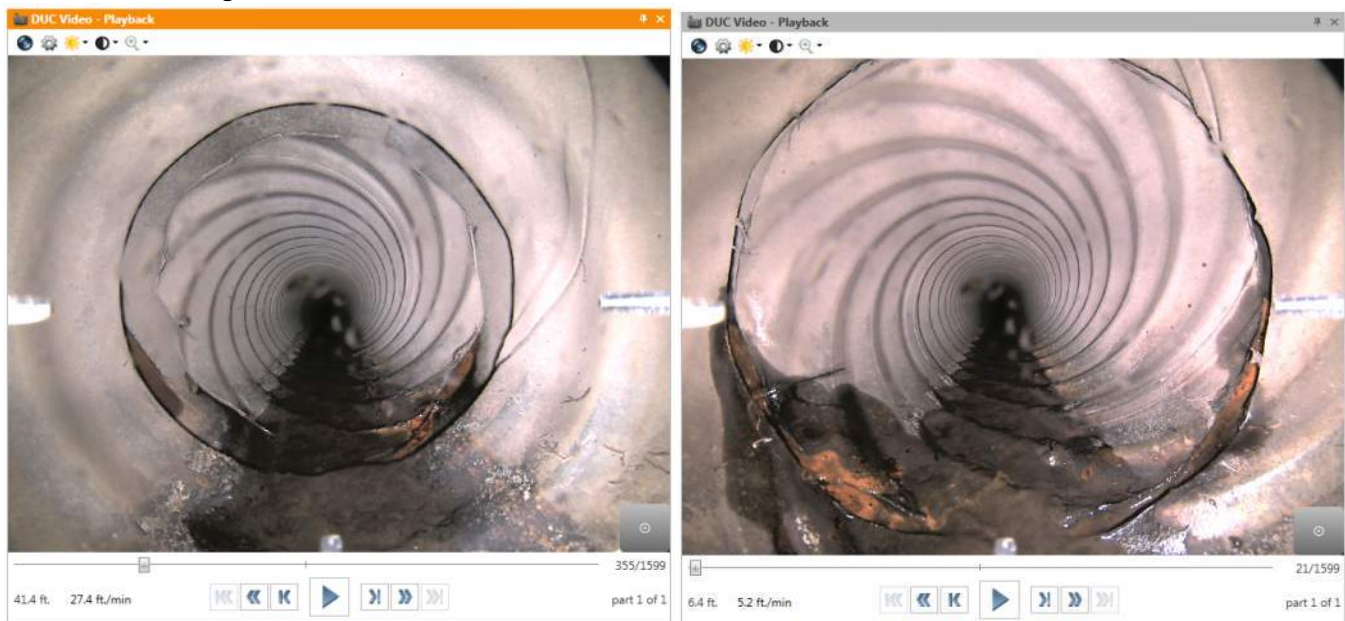
Lois Drive and 32nd Avenue Pathway MOA Pipe #30570 - W. 31st Ave (east of Doris St)

Miscellaneous/Defect Notes: Minor metal loss/corrosion present throughout length of pipe.
Offset joint at 152.1 feet. Mineralization/Infiltration at pipe joint
at 6.4 feet, 21.5 feet, 72.3 feet and 121.8 feet. Joint separation at
41.7 feet.

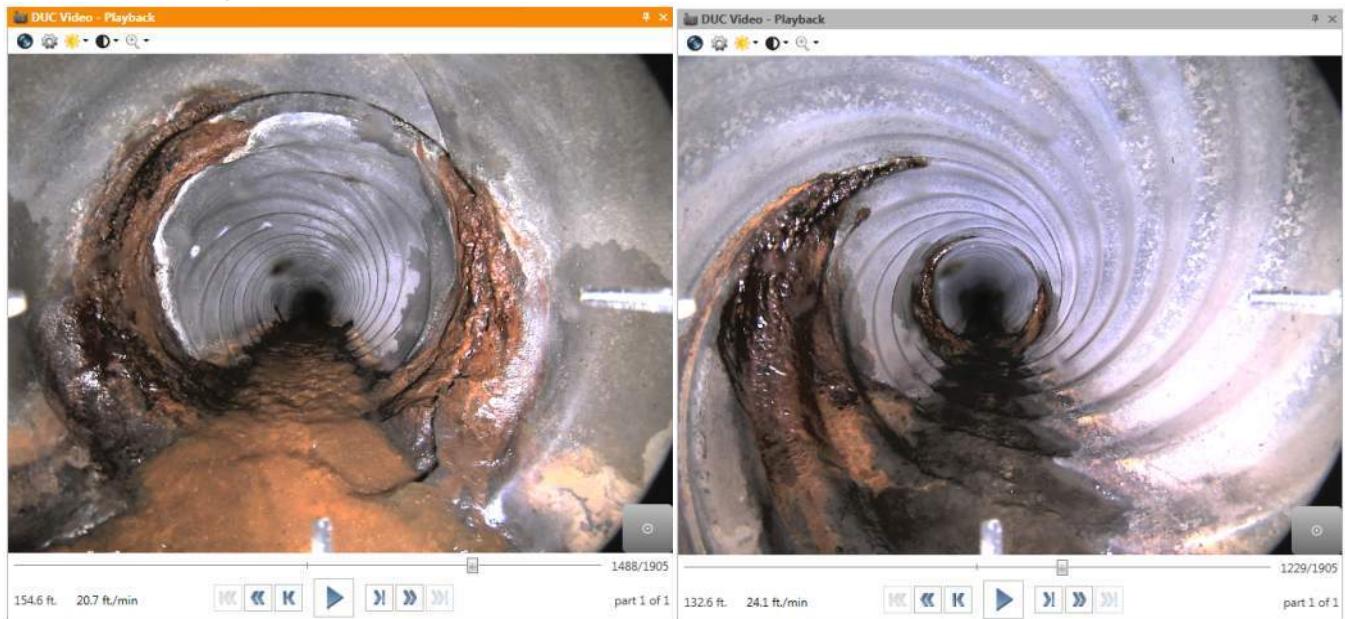
Lois Drive and 32nd Avenue Pathway MOA Pipe #13603 - W. 31st Ave (west of Doris St)

- Pipe 13603: Moderate to significant mineralization and metal loss/corrosion near outlet end of pipe.
- Pipe 27885: Two blind connections deposit moderate to significant mineralization into interior of pipe. Per the CCTV operator, this pipe was previously lined and the liner is showing damage at several locations

Miscellaneous/Defect Notes: Minor metal loss/corrosion present from 0 feet to 143.1 feet. Moderate to significant metal loss/corrosion present from 143.1 feet to end of pipe. Mineralization/infiltration near flow line at 4 o'clock position at 131.1 feet. Mineralization/infiltration near along CMP seam at 9 o'clock position at 132.6 feet. Significant mineralization/infiltration at pipe joints at 114.2 feet, 134.3 feet & 154.9 feet. Surface damage/corrosion at 10 o'clock & 2 o'clock at 55.0 feet.

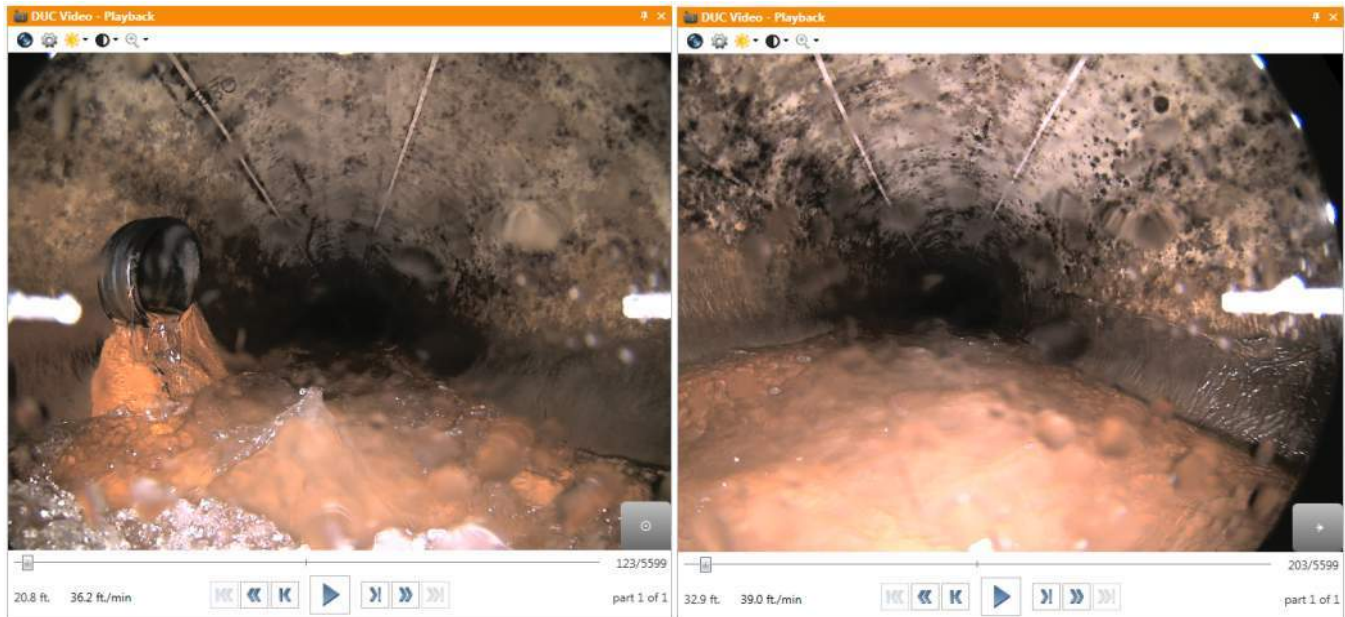
MOA Pipe #27885 - Fish Creek Alignment (between Willow St & Doris St)

Miscellaneous/Defect Notes: According to CCTV operator, this pipe was previously lined with CIPP. Operator noted lining failures at 32.9 feet, 60.3 feet, 131.6 feet & 182.1 feet. CPEP lateral at 9 o'clock position at 21.3 feet with significant mineralization at discharge point. CMP lateral at 11 o'clock position at 133.2 feet with moderate mineralization at discharge point.

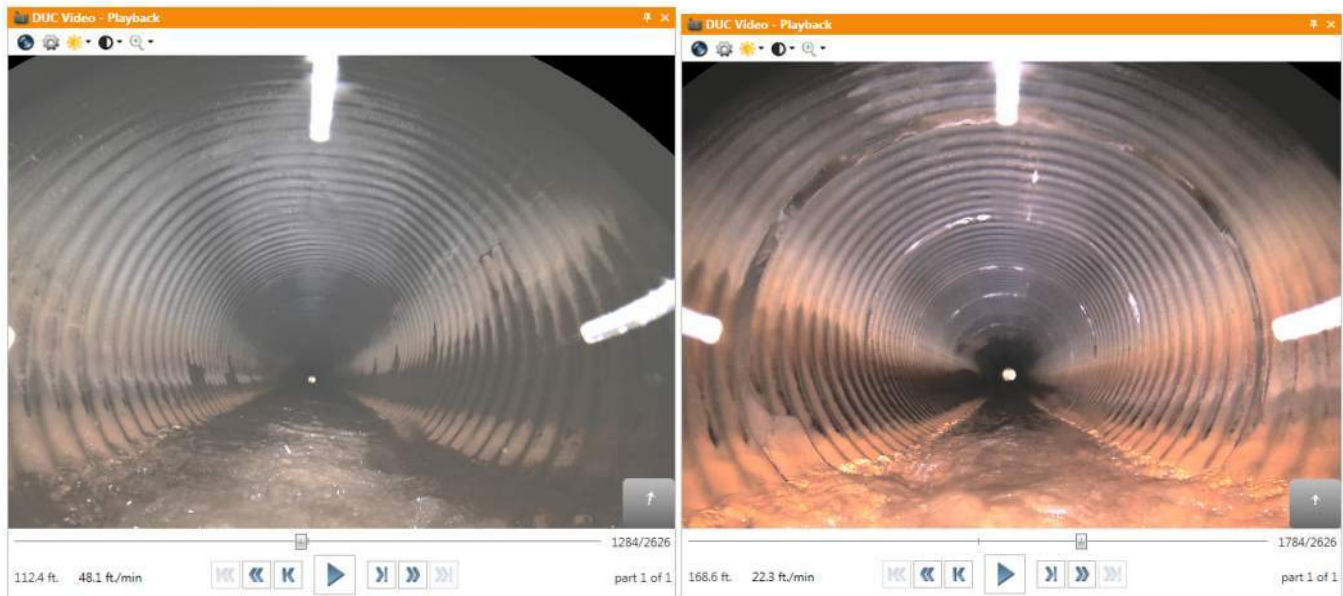
Lois Drive and 32nd Avenue Pathway MOA Pipe #33747 - Fish Creek Alignment (crosses Willow St)

- Pipe 33747: Crown of pipe deformed several inches. Several holes and metal loss/corrosion identified at multiple locations along pipe segment.

Miscellaneous/Defect Notes: Multiple holes in pipe from 7 to 9 o'clock position at 7.1 to 11.3 feet. Tee connection at 12 o'clock position at 12.9 feet. Hole in pipe at 4 o'clock position at 45.9 feet. Crown of pipe deformed several inches at 112.4 feet. CCTV camera submerged at 129.5 feet. Joint separations at 148.0 feet, 168.6 feet & 189.0 feet. Angle point in pipe at 263.7 feet.

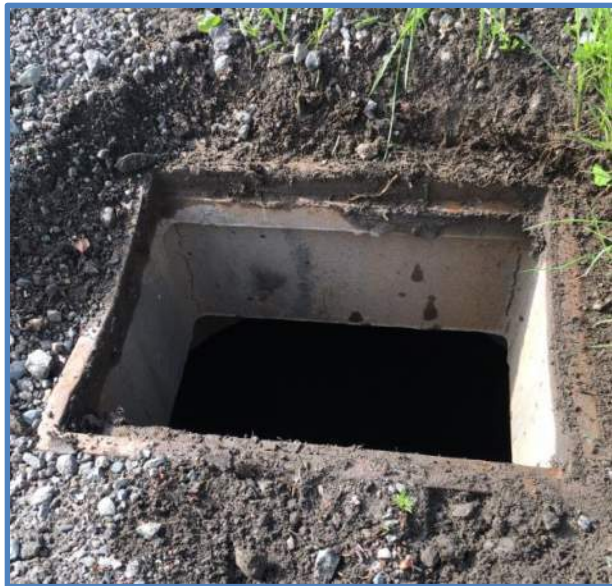
Photo 3 - Frame & Reducing Slab

- Grout spalling at pipe penetration
- Non-standard inlet, 11.5" x 15", rectangular, frame depth 10"
- No grade rings, frame placed on reducing slab

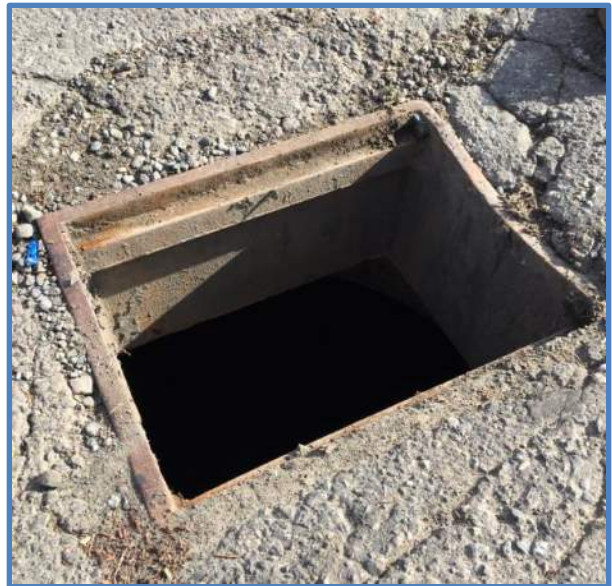
Photo 4 - Frame & Reducing Slab

- Non-standard inlet, 11.5" x 15", rectangular, frame depth 10"
- No grade rings, frame placed on reducing slab
- Grout spalling around pipe penetration
- Metal loss at invert of pipe

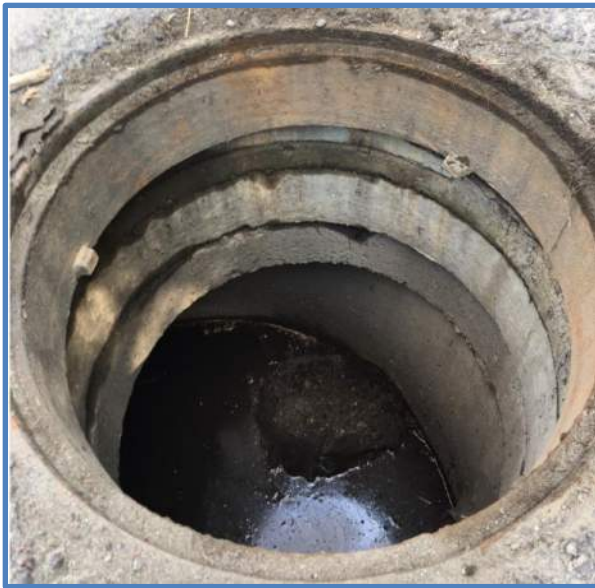
Photo 3 - Frame, Grade Rings & Reducing Slab

- Flat intake lid
- Minor vertical cracking in 6" grade ring
- Minor grout spalling in pipe penetration
- Significant debris in sump

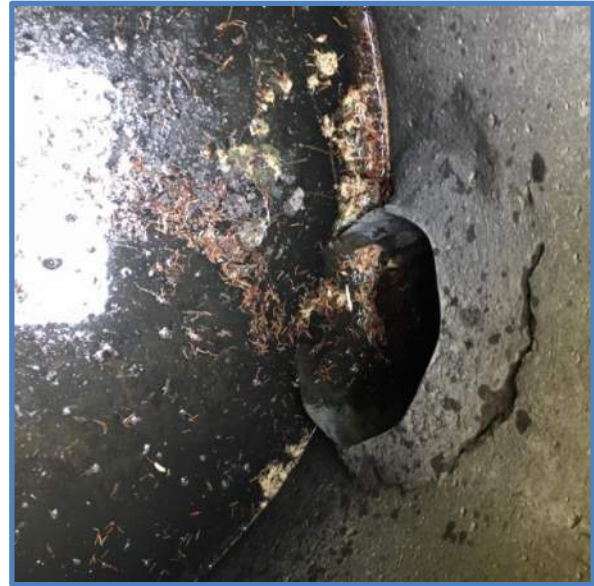
Photo 4 – Outlet Pipe Penetration

- Type 2 curb inlet, 24" x 18"
- Curb inlet is at skewed angle from curb line
- Grade ring placement is offset from frame and reducing slab
- Crack in grout above pipe penetration

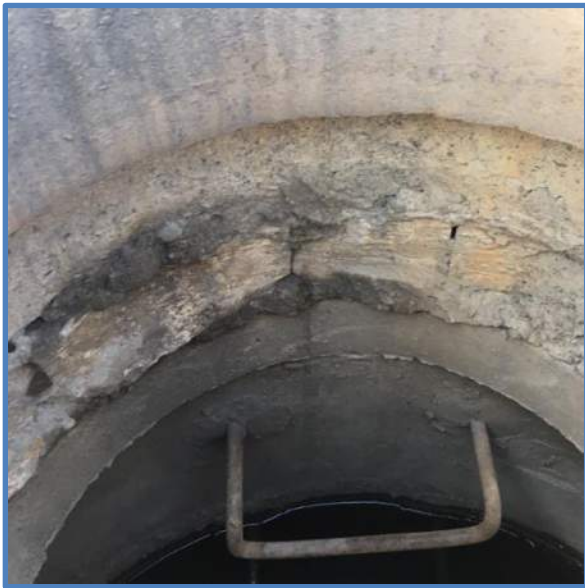
- 1 layer of non-standard grade ring is composed of bricks (in poor condition)
- No cone, grade rings on reducing slab
- 2 visible non-standard steel ladder rungs, 17" apart
- Non-standard frame with 10" height
- Non-standard lid
- Some sediment buildup in pipes
- Grout cracking at west pipe penetration
- NW pipe (8" plastic) was not shown in MOA record drawings and MOA drainage arcgis map

Photo 3 – Frame, Brick Grade Ring, Reducing Slab, and Ladder Rung

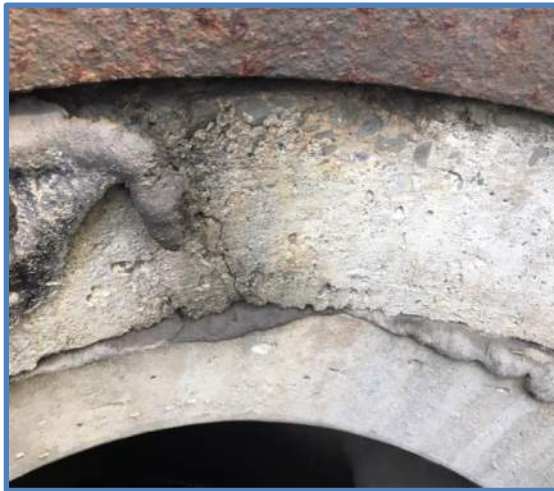
- 4 non-standard steel ladder rungs
- Buried MH cover in gravel
- Vertical cracking in grade ring
- Grade ring placement is offset from cone and frame

Photo 3 - Cracking in Grade Ring
