IMAGE DRIVE / REFLECTION DRIVE AREA

Road Reconstruction

DRAFT DESIGN STUDY REPORT

DECEMBER 2017

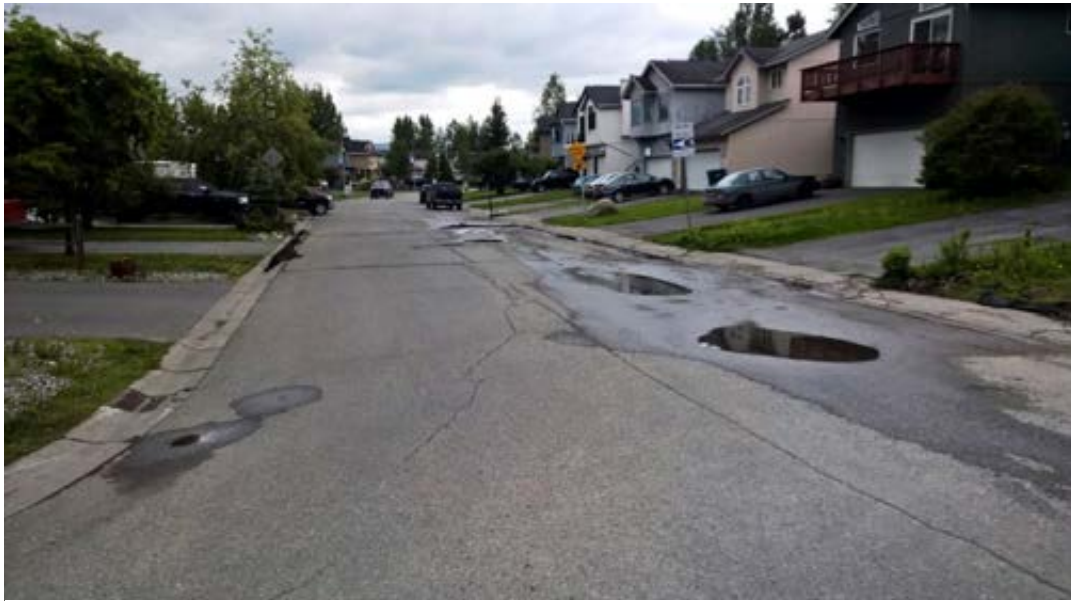
The majority of roadways in the project area were constructed in the 1980s and have reached the end of their useful life. Ponding along the project roadways and curbs, as shown in the photo below, are normal occurrences after rain events. High ground water and soil conditions have resulted in corroded and failing storm drain pipes throughout the project limits. Road conditions include moderate frost cracking and persistent transverse cracks in the pavement. Additionally, the existing Image Drive storm drain system outfalls into a stream with a submerged outlet and during storm events the stream backs up into the existing storm drain system. The purpose of the project is to reconstruct the roadways and associated failing storm drain system, improve drainage, alleviate maintenance issues, upgrade pedestrian facilities to meet current requirements, and provide a stable roadway base to extend the life of the streets.

Reflection Drive at Image Drive intersection (north) viewing south

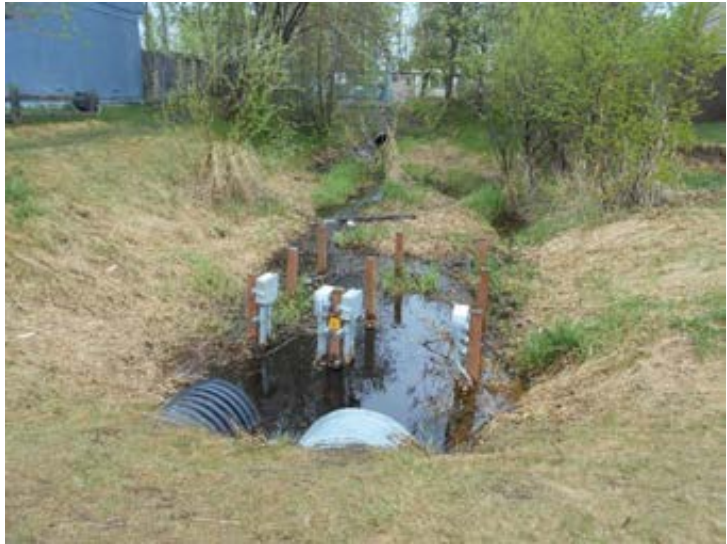
Reflection Lake Creek extends from Reflection Lake and meanders northwards within the project limits and along the back of some of the parcels. Reflection Lake Creek crosses the project area roadways in culverts at two locations: Reflection Drive on the south side of the project and Image Drive at the north side. Both these culvert crossings were upgraded in 2013 as part of the MOA PM&E Riviera Terrace Storm Drain Replacement project (Project Number 08-48) with a 36-inch diameter culvert and a 24-inch overflow culvert at each crossing. Heat trace was also installed in each of the culvert creek crossings and within the stream channel at both the inlet and outlet of the culverts. The culverts were installed with stream substrate in the 36-inch diameter culvert in order to promote fish passage. North of the Image Drive crossing, the stream enters an open channel as shown in the photo to the right then outfalls through a 60-inch diameter piped storm drain system with stream substrate that was also installed as part of the 2013 Riviera Terrace Storm Drain Replacement project. The 60-inch storm drain pipe is located within a storm drain easement on the Riviera Terrace Trailer Court property and discharges to the South Fork of Chester Creek.

Image Drive culvert crossing outfall viewing north

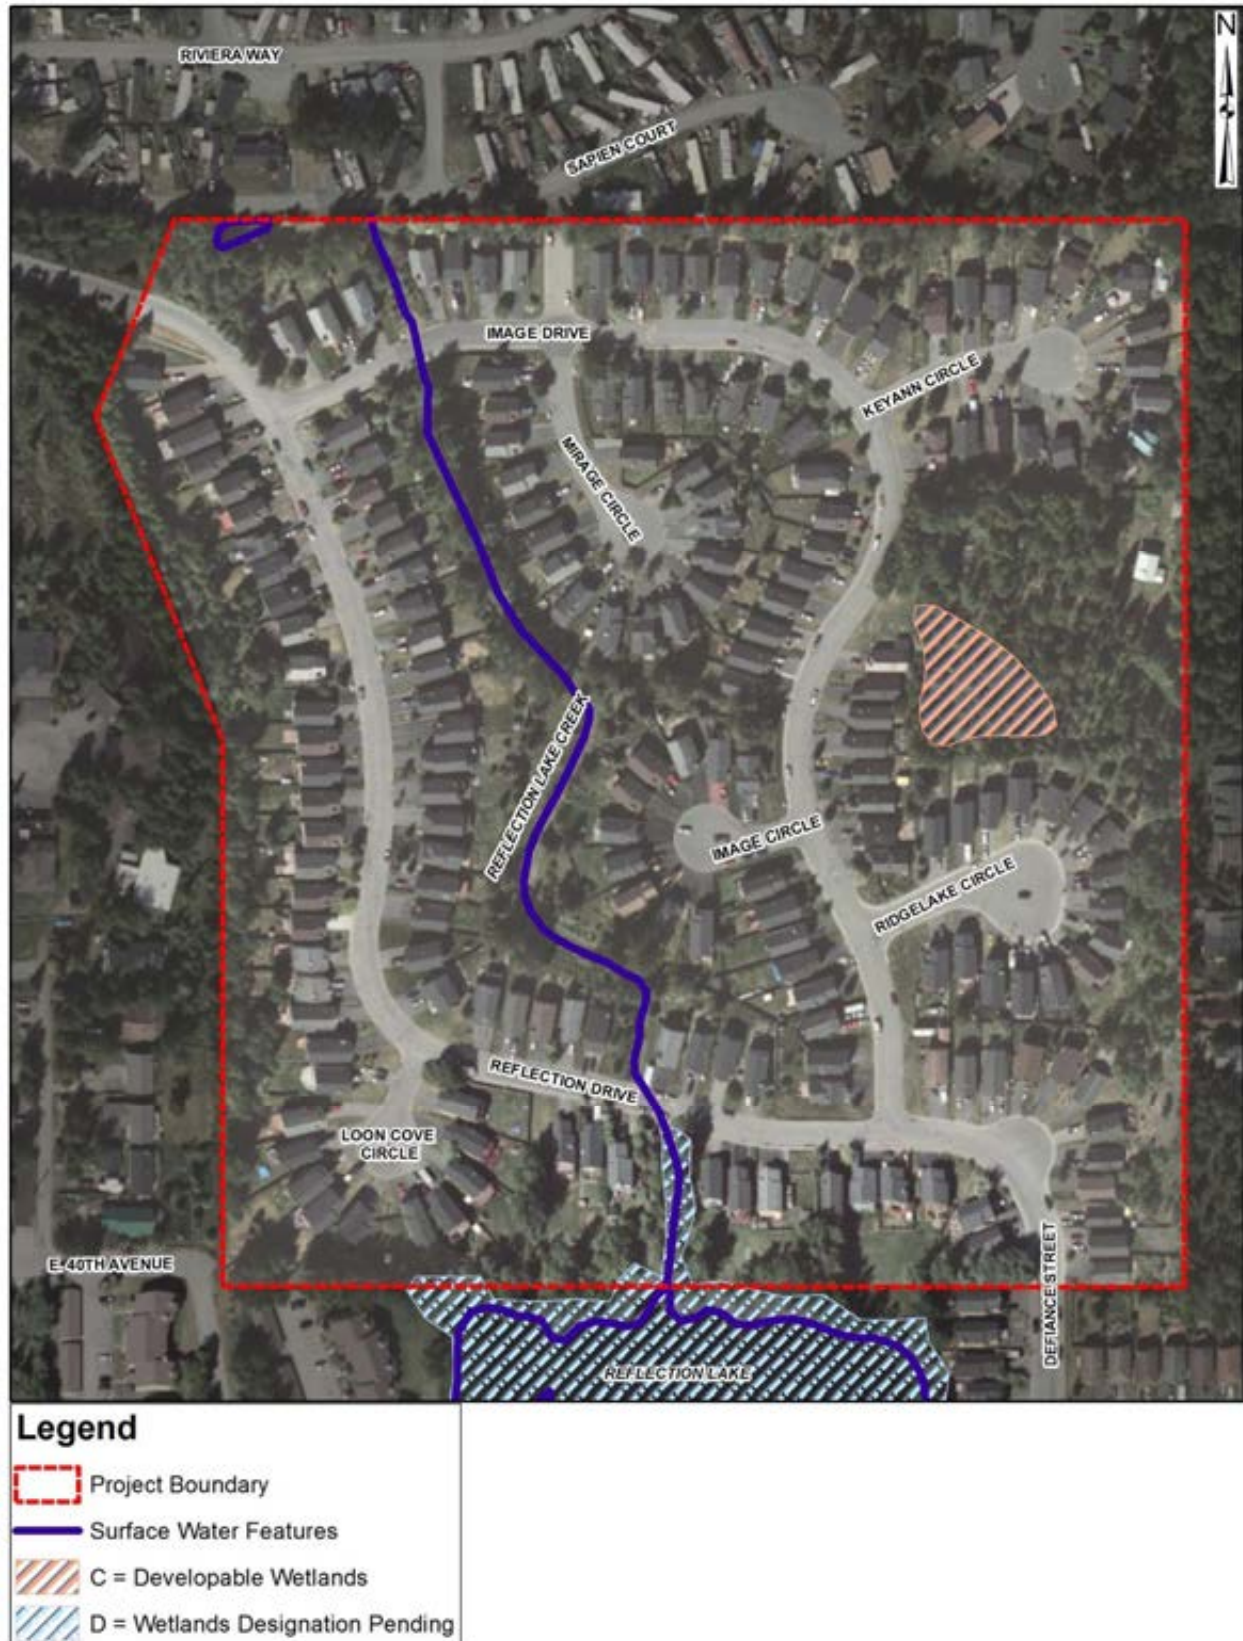
Figure 3 - Wetlands Map (wetlands from MOA WMS GIS)

The MOA Wetlands Atlas shows an area of class “C” wetlands (ID# 338) within the project area measuring approximately 0.5 acres. There is also a class “D” wetland located south of the project limits that encompasses Reflection Lake and a portion of Reflection Lake Creek. See FIGURE 3 for location of wetlands within the project area.

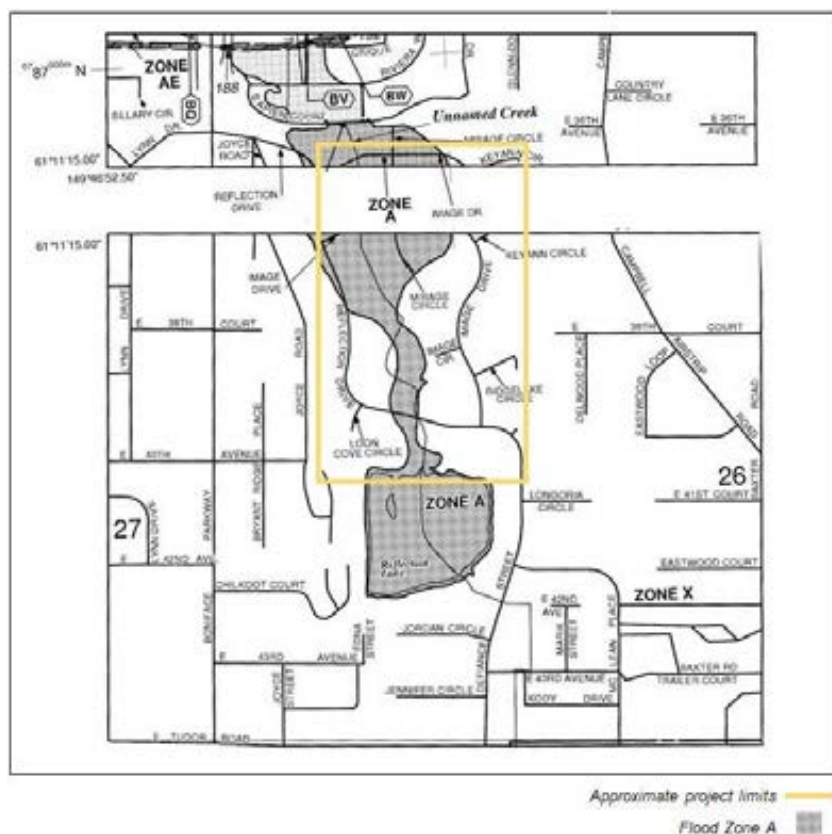
Figure 4 - FEMA Flood Plain Map

A review of the Federal Emergency Management Agency (FEMA) Flood Insurance Rate Maps (FIRM) #0200050767D and #0200050759D reveal that portions of the project area are within Zone A, a special flood hazard area (SFHA) subject to inundation by a 100-year flood. Mirage Circle, portions of Reflection Drive, and portions of Image Drive in the vicinity of Reflection Lake and Reflection Lake Creek are within the floodplain (see [FIGURE 4](#) for the FEMA flood plain map). These areas do not have a base flood elevation (BFE) determined by FEMA but are within the floodplain and a MOA Flood Hazard Permit will be required for work within Reflection Lake Creek floodplain.

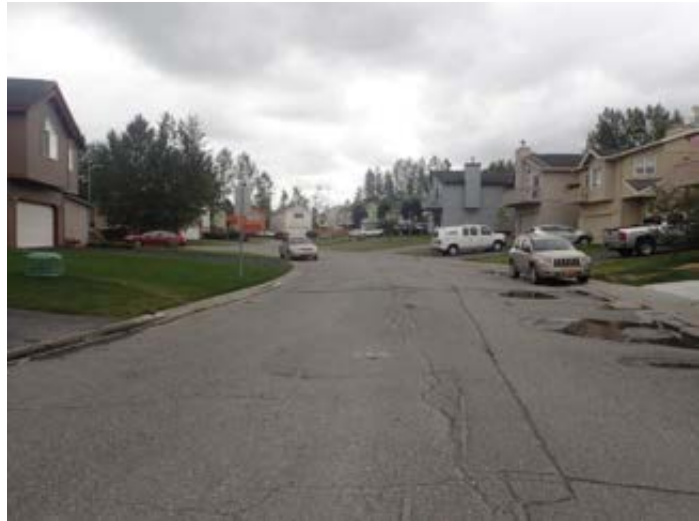
Reflection Drive viewing south, parked car on right encroaching onto sidewalk

Reflection Drive and Image Drive are both approximately 33 feet wide measured from back of curb to back of curb (29 feet of pavement). Type 2 (rolled) curb and gutter is installed on all roadways throughout the project limits in order to accommodate the closely spaced driveways. On-street parking is allowed throughout the project limits even though space is limited due to the large number of driveways. Parked cars on-street often encroach onto the sidewalk as shown in the photo below. The posted road speed limit is 25 miles per hour (mph).

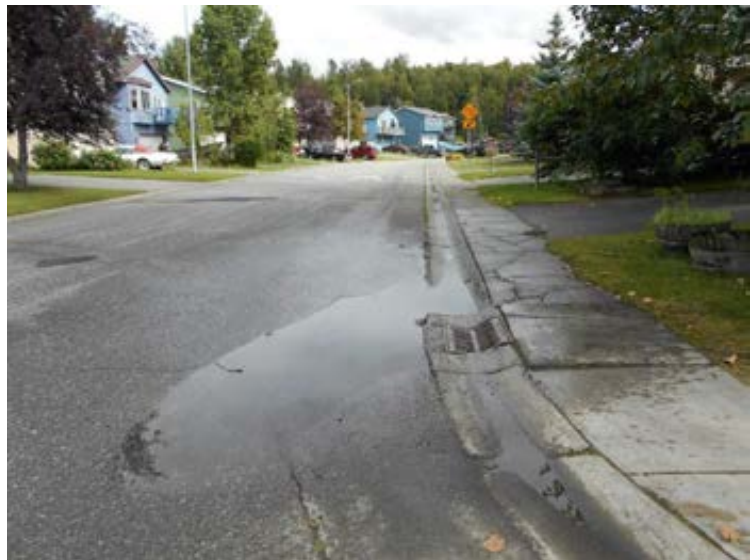
The existing conditions of the roadway pavement in the project area include frost cracking, especially on the west and north parts of the project. There are also persistent transverse cracks in the pavement throughout the project roadways that are likely related to the many utility connections and differential frost heave within the trench backfill. There are frequent pavement patches at manholes, indicative of

Image Drive at Mirage Circle viewing east

movement of the manholes relative to the road surface, as well as numerous depressions along the curb and gutter. The concrete sidewalks and curb and gutter are badly broken in many areas as shown in the photo above. The broken concrete is likely caused by poor subgrade conditions or frost movement, which is exacerbated by vehicles parking on the sidewalks and poor drainage leading to saturated foundations materials.

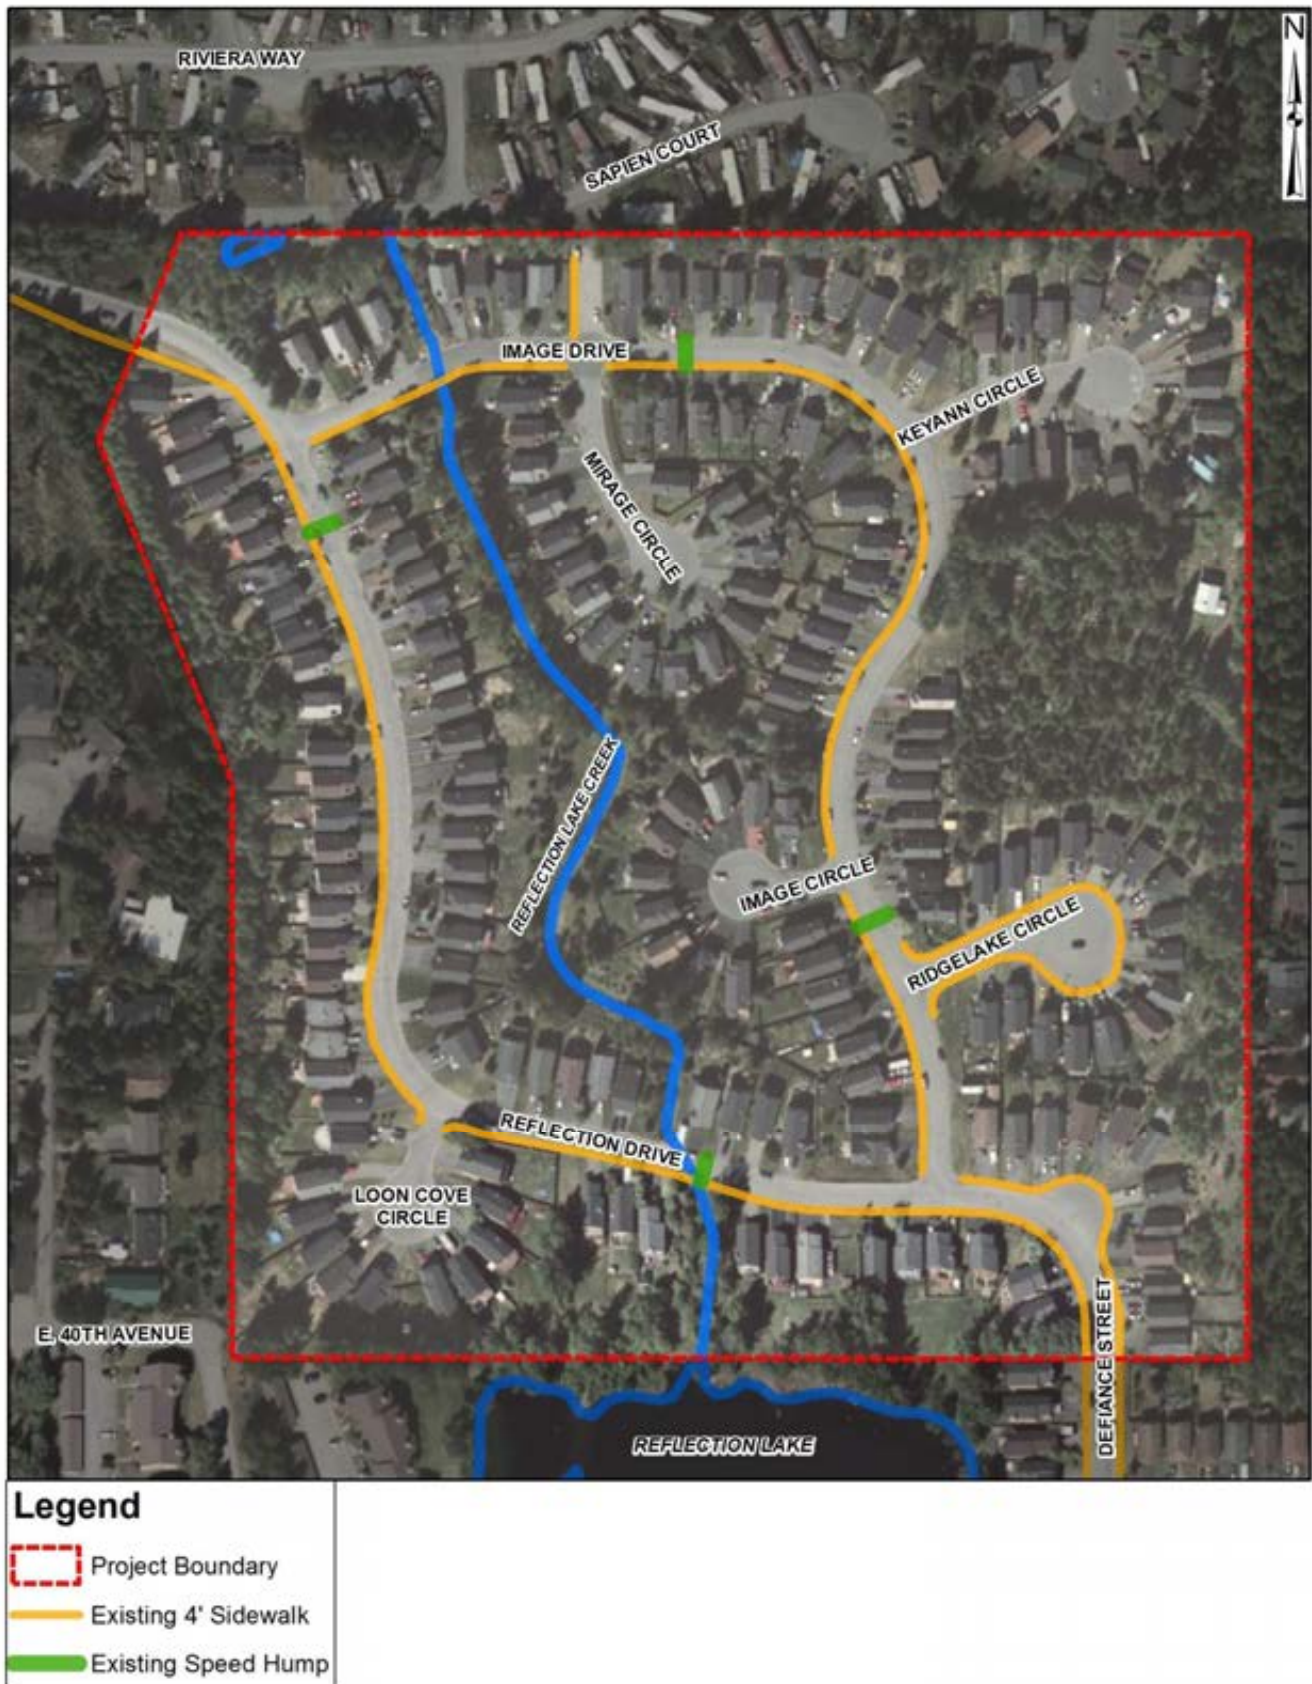
Figure 5 - Existing Sidewalks and Speed Humps

Pedestrian facilities within the project limits include 4-foot wide sidewalks attached to the back of curb located along the west and south side of Reflection Drive and Image Drive. Just north of the project limits the sidewalk is detached along the south side of Reflection Drive and then connects to Boniface Parkway. There is also a sidewalk on the west side of Mirage Circle (North) and along both sides of Ridgelake Circle and Defiance Street. During multiple site visits, cars were observed parked on the sidewalk and some pedestrians tend to use the roadway rather than the sidewalk because of this. No specially designated bicycle facilities occur within the project area. There are not ADA compliant curb ramps at the intersections; the curb ramps typically lack accessible curb type and/or detectable warning panels. See FIGURE 5 for location of existing sidewalks within the project limits.

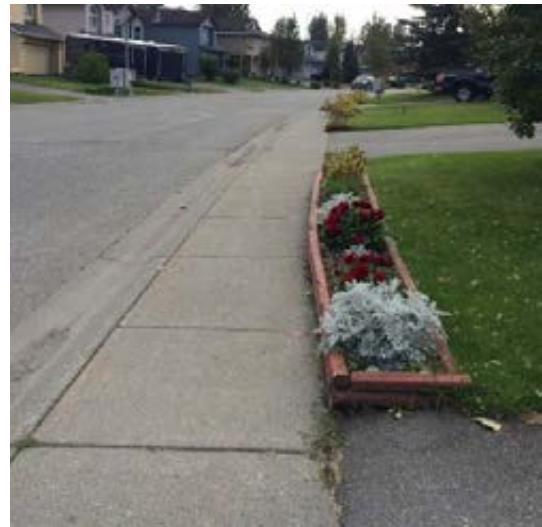
In many instances, landscaping extends to the back of the sidewalk or back of curb, and in some areas private homeowner improvements, such as mulched planting beds, decorative edging, and large tree plantings take place in the right-of-way (ROW). Decorative fences also extend to the back of curb in a few places. Small landscaped areas consisting of two to three-foot diameter boulders, occasional shrub or perennial plantings, and lawn occur at the neighborhood

Private improvements as those pictured above on Reflection Dr occur at many locations within the ROW

intersections where space in the ROW allows. Some of these private improvements cause problems with roadway maintenance, particularly snow removal and storage.

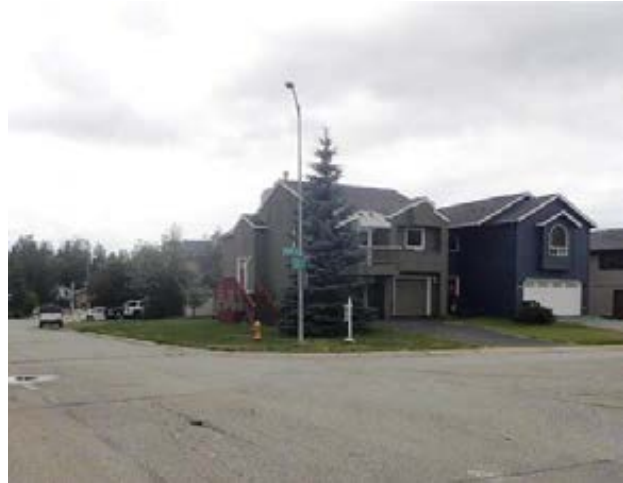
Existing street light at Image Drive/Reflection Drive intersection (south) viewing northwest

There are existing street lights located at all the intersections, intermittently along Reflection Drive/Image Drive and within each of the cul-de-sacs. The existing street lighting system in the project area includes 27 direct embedded, 30-foot lighting poles with LED fixtures that are owned and maintained by the MOA. The existing light poles do not meet the lighting requirements of the MOA Design Criteria Manual (DCM) or the current construction requirements of the MOA and several poles will be directly impacted by this project.

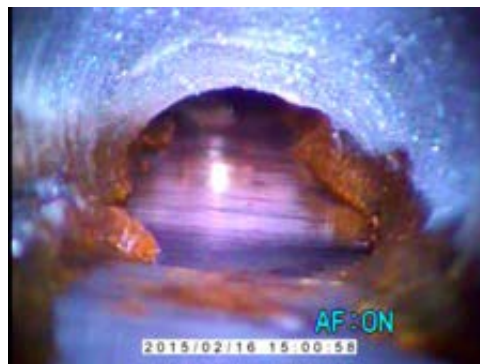
The project area currently has two main piped storm drain systems that extend the length of Reflection Drive and Image Drive, with several connecting side street systems. These systems were constructed of corrugated metal pipe (CMP) and are approximately 30 years old. The CMP pipe has been found to be structurally unsound in some locations and in high risk of collapse due to corrosion. The inspection photo to the right was taken in 2015 and shows a belly in the existing Reflection Drive 18-inch CMP pipe and signs of pipe corrosion.

18-inch CMP storm drain in Reflection Drive (photo courtesy Steph Engineering, LLC)

Replacement project, several existing CMP pipe segments were identified as having significant invert corrosion issues. The Image and Reflection Drive systems were constructed primarily with CMP approximately 30 years ago, therefore corrosion and other pipe integrity issues likely exist throughout the project corridor.

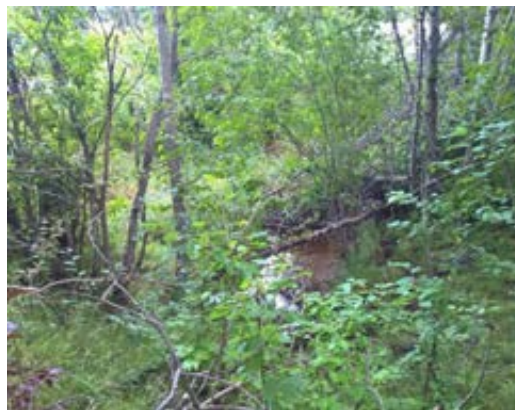
Stormwater runoff from the Image Drive system is currently not being treated prior to discharging into Reflection Lake Creek. As noted above, the Reflection Drive system outfalls into a sedimentation basin located between Reflection Drive and Sapien Court. Although this basin is not

Existing overgrown sedimentation basin

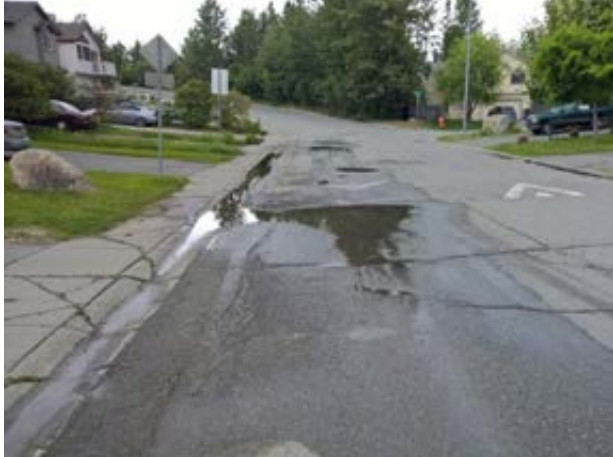
Significant ponding occurs throughout the project limits due to flat grades and inadequate surface drainage conveyance. Poor drainage typically leads to roadway degradation, such as heaving, cracking, and pavement failure over time as shown in the photo to the right. Image and Reflection Drive are both showing signs of pavement distress due to these issues.

*Ponding along the west side of Reflection Drive
viewing north*

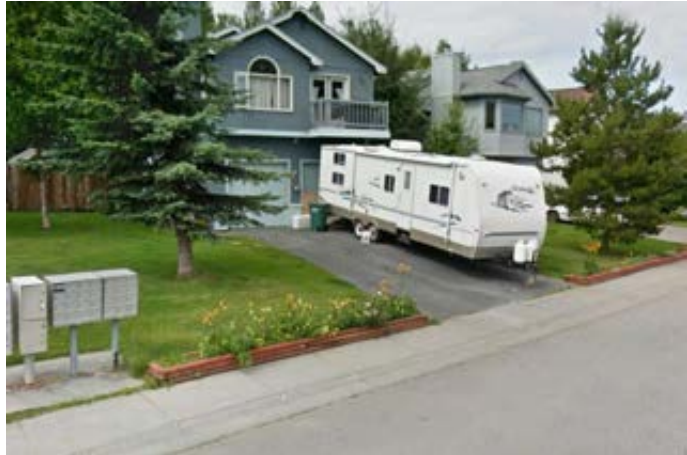
*Steep driveway and planters in the ROW along
Reflection Drive*

- Many existing driveways have no landings and many have grades steeper than MOA DCM maximum allowable grade of 10%.
- Roadway grades are typically flat, as low as 0.1% percent in some places. There are known surface drainage issues in the project area.

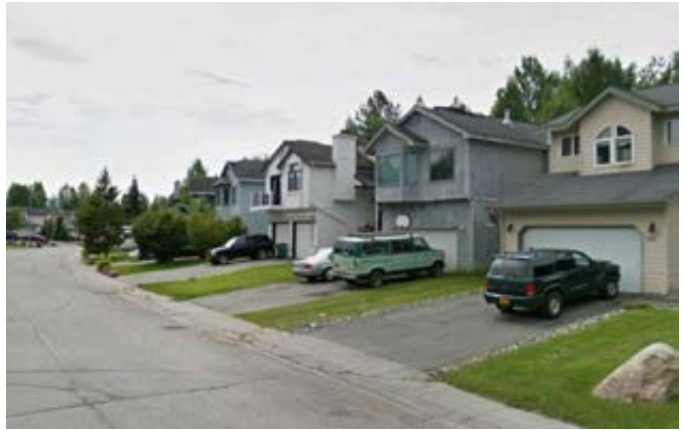
Closely spaced and steep driveways along west side of Reflection Drive viewing south

each driveway as well as where the proposed footing drain services are to be located. Since many existing driveway widths encompass most of the lot frontage, the proposed footing drain services often times have to be located within the driveway. In such cases this will require replacing the driveway to approximately 5 feet beyond the proposed footing drain service located at the property line.

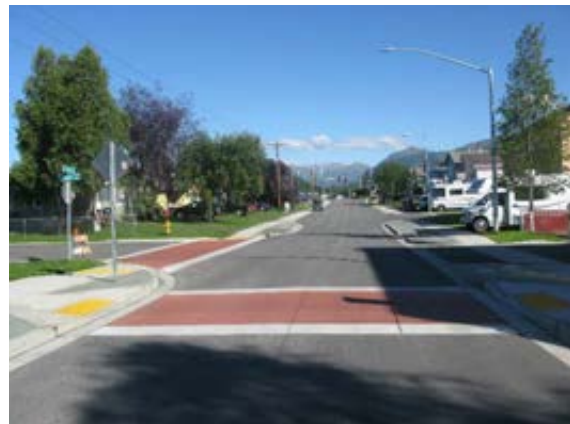
Colored crosswalks on E. 4th Avenue at Camelot Drive

Colored concrete crosswalks can be used for crosswalks at higher volume side streets and in conjunction with other traffic calming measures. Colored concrete crosswalks provide additional visual guides

for motorists and allow for a safer crossing. However, the cost to install colored concrete is very expensive.

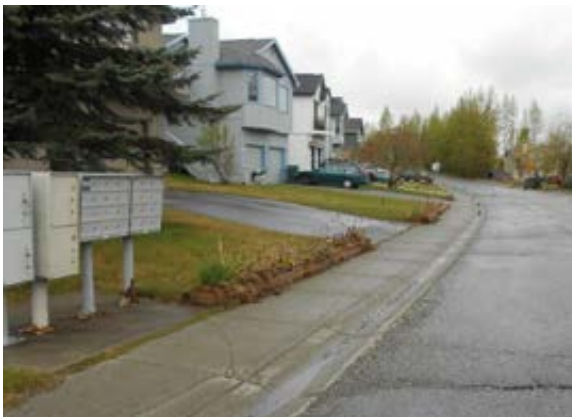
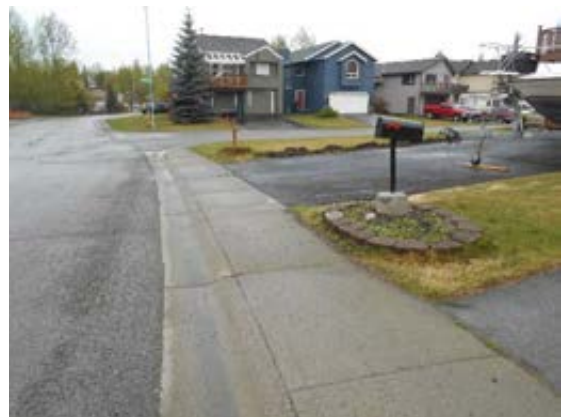
Existing cluster mailboxes on Reflection Drive and individual mailboxes on Defiance Street

Residents along Reflection Drive, Image Drive and all cul-de-sacs excluding Keyann Circle have cluster mailbox service. Residents along Defiance Street (east of Image Circle) and on Keyann Circle have individual mailbox service. Cluster mailboxes are desirable to the MOA and United States Postal Service (USPS) as they facilitate maintenance, reduce delivery times, and provide a secure receptacle for residents. Another advantage of cluster mailboxes when sidewalks are present is they can be placed behind the sidewalk instead of an individual mailbox being placed in the sidewalk. Mailboxes placed in the sidewalk are a safety hazard for pedestrians and hinder snow removal.

Existing cluster mailboxes will likely be re-installed on concrete bases in approximately the same locations. Cluster mailboxes are often installed behind an attached sidewalk or back of curb as the postal carrier must already exit the vehicle to deliver mail.

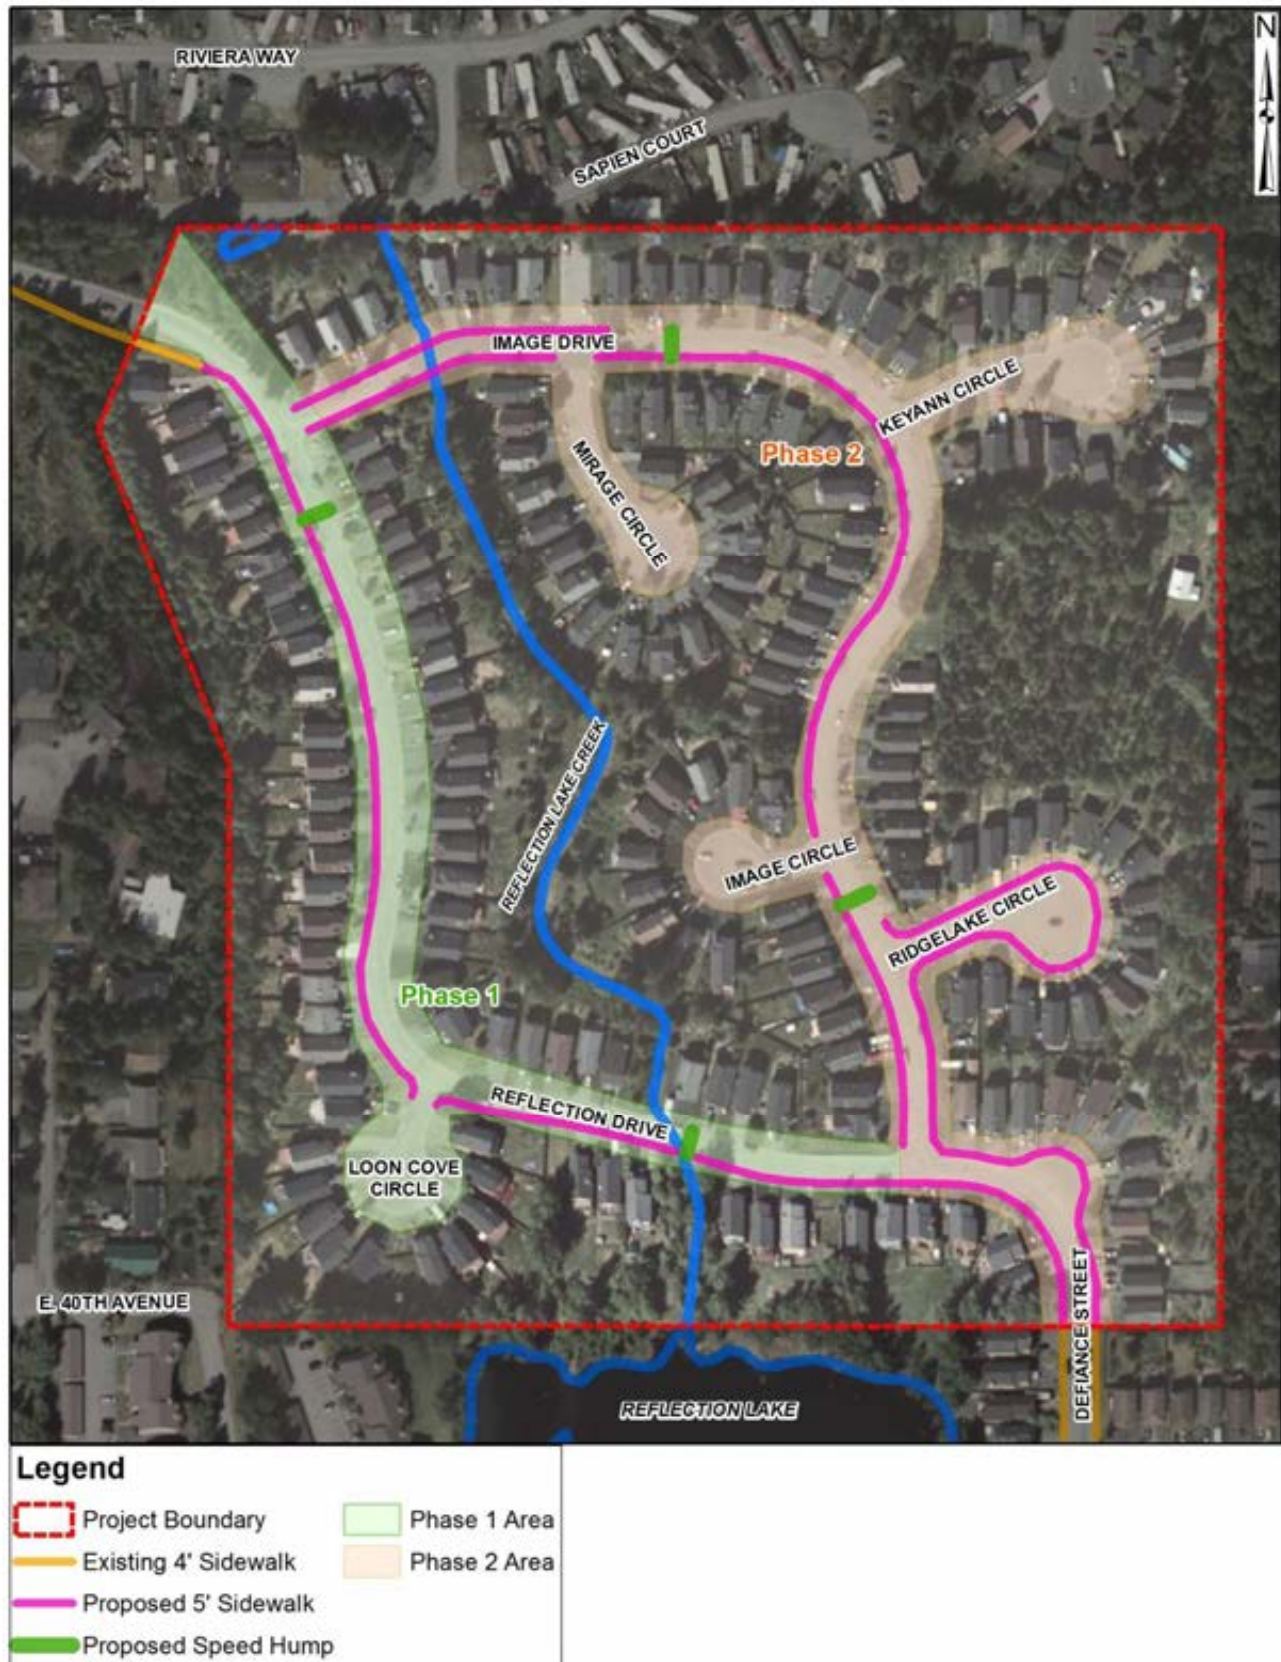
Figure 11 - Proposed Sidewalks, Speed Humps & Construction Phasing

The MOA may choose to phase the construction of this project in order to coincide with funding requests and to minimize impacts to the entire neighborhood. See FIGURE 11 for potential construction phasing limits.

The existing 4 speed humps along Reflection Drive and Image Drive are recommended to be re-installed as part of this project.
