Municipality of Anchorage
Project Management & Engineering Department

IMAGE DRIVE / REFLECTION DRIVE AREA ROAD RECONSTRUCTION

SUMMARY OF PROPOSED IMPROVEMENTS

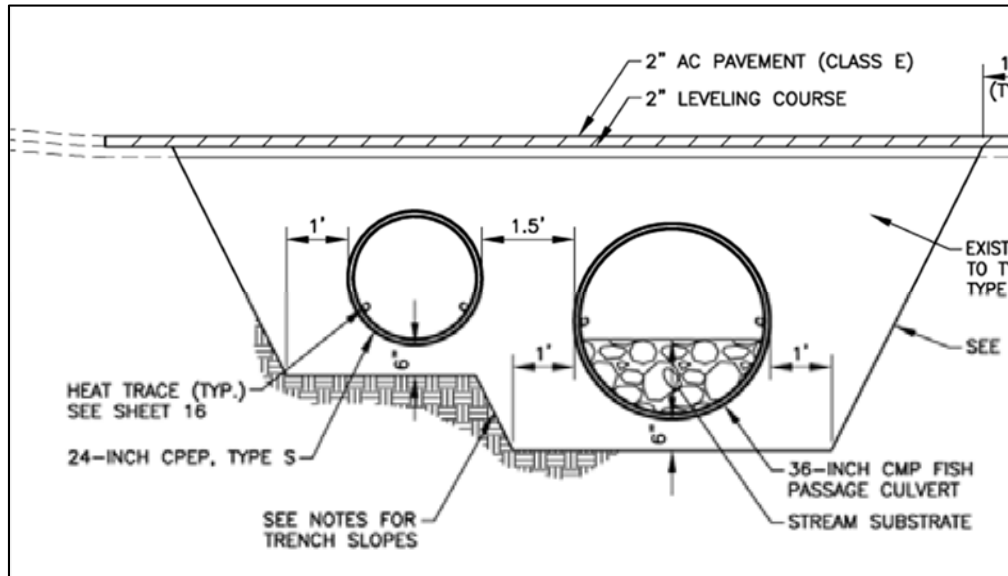
- B. CRW confirmed after the meeting that the Reflection Lake stream culverts that were installed with the MOA PM&E Riviera project did have stream substrate installed in one of the culverts to facilitate fish passage (see Typical Culvert Crossing Detail from the plan set below).

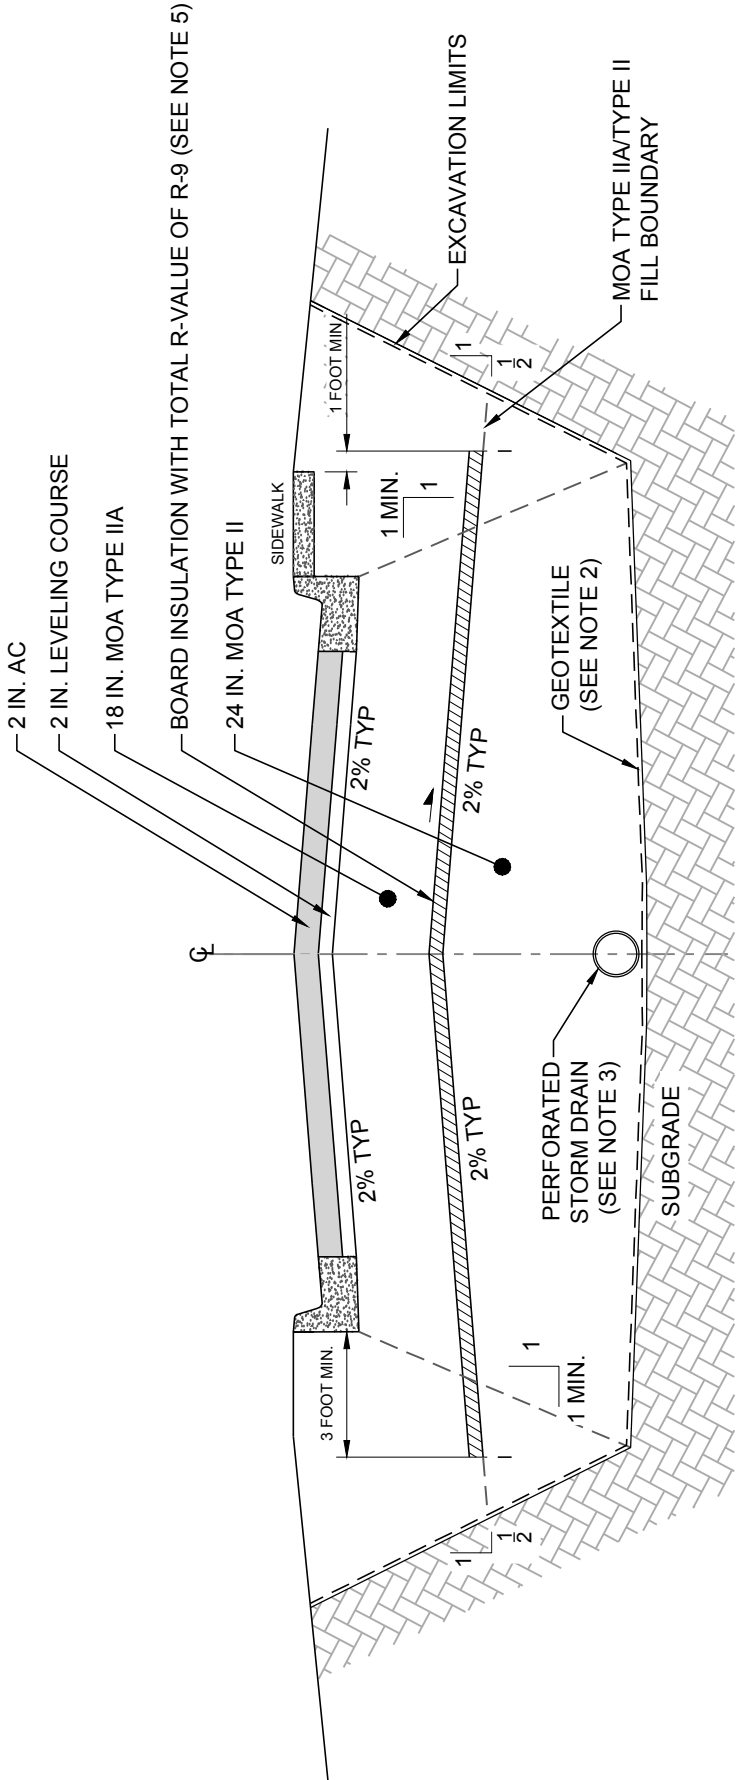
PROJECT NO.	CONTROL	REV.	FIGURE
1523636	C		4

TITLE
TYPICAL INSULATION SECTION WITH PERFORATED STORM DRAIN

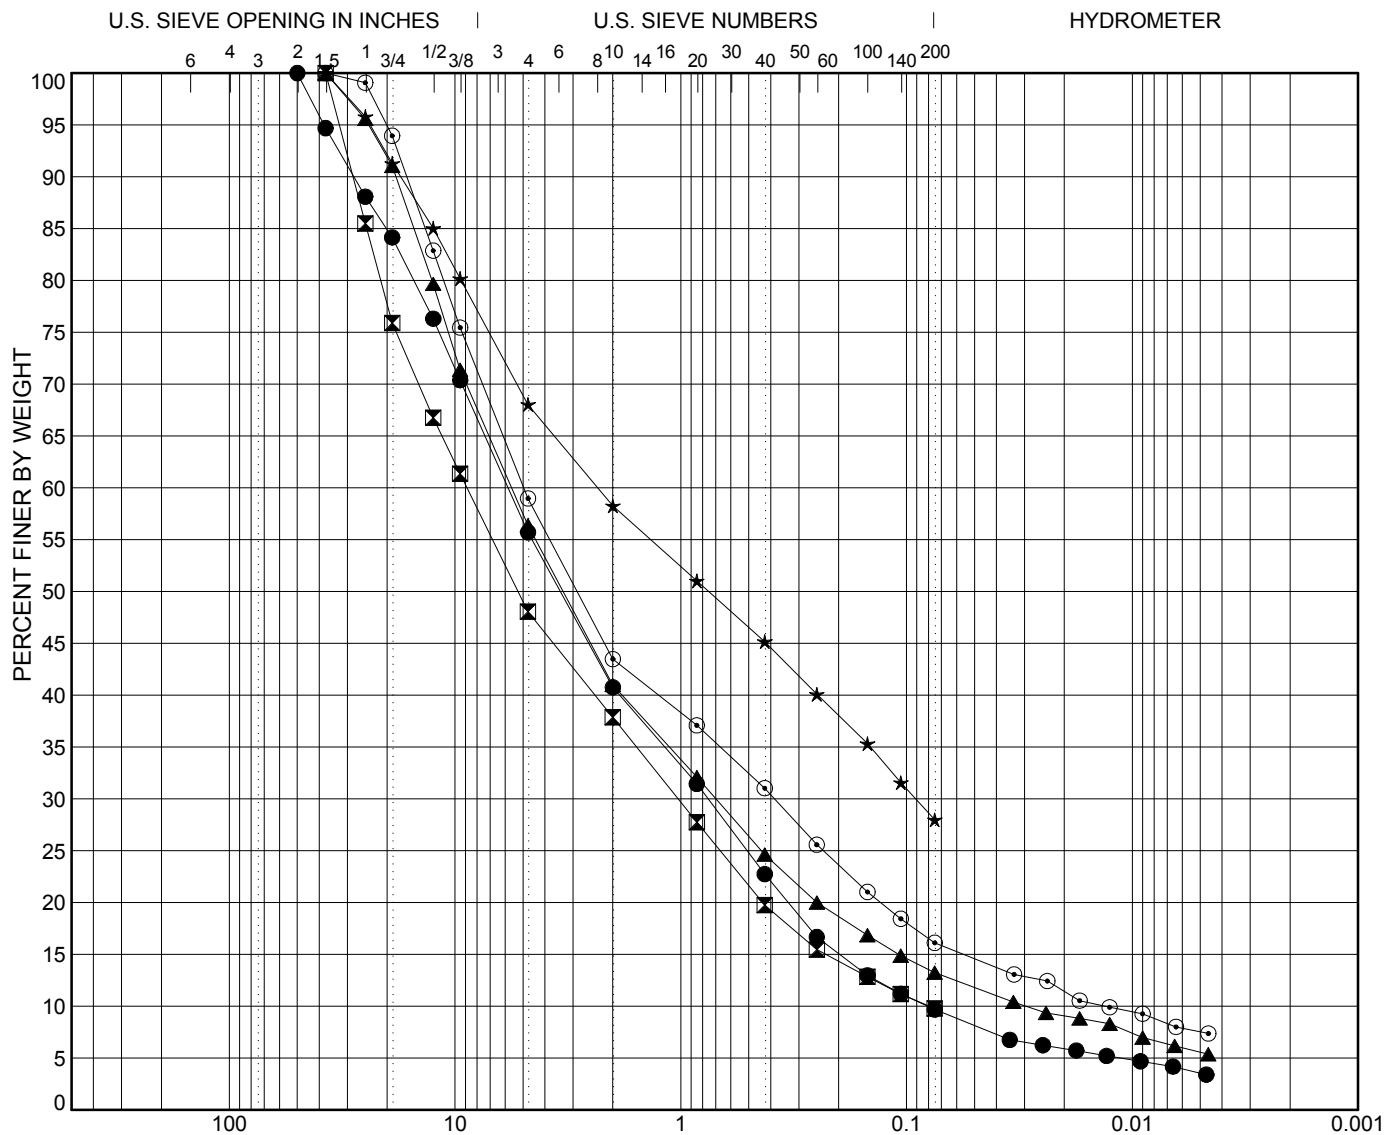
Sample Location	Sample Number	Depth (ft)	USCS Classification	Cc	Cu	% Gravel	% Sand	% Fines	% < 0.02 mm
●	BH-01	2	2.5	well-graded sand with silt and gravel (SW-SM)	1.2	72.2	44	46	10	6
⊠	BH-02	2	2.5	well-graded gravel with silt and sand (GW-GM)	1.5	111.7	52	38	10	
▲	BH-03	1	0.0	silty gravel with sand (GM)	3.0	190.1	44	43	13	9
★	BH-04	2	2.5	silty sand with gravel (SM)	-	-	32	40	28	
⊙	BH-05	1	0.0	silty sand with gravel (SM)	2.3	374.5	41	43	16	11

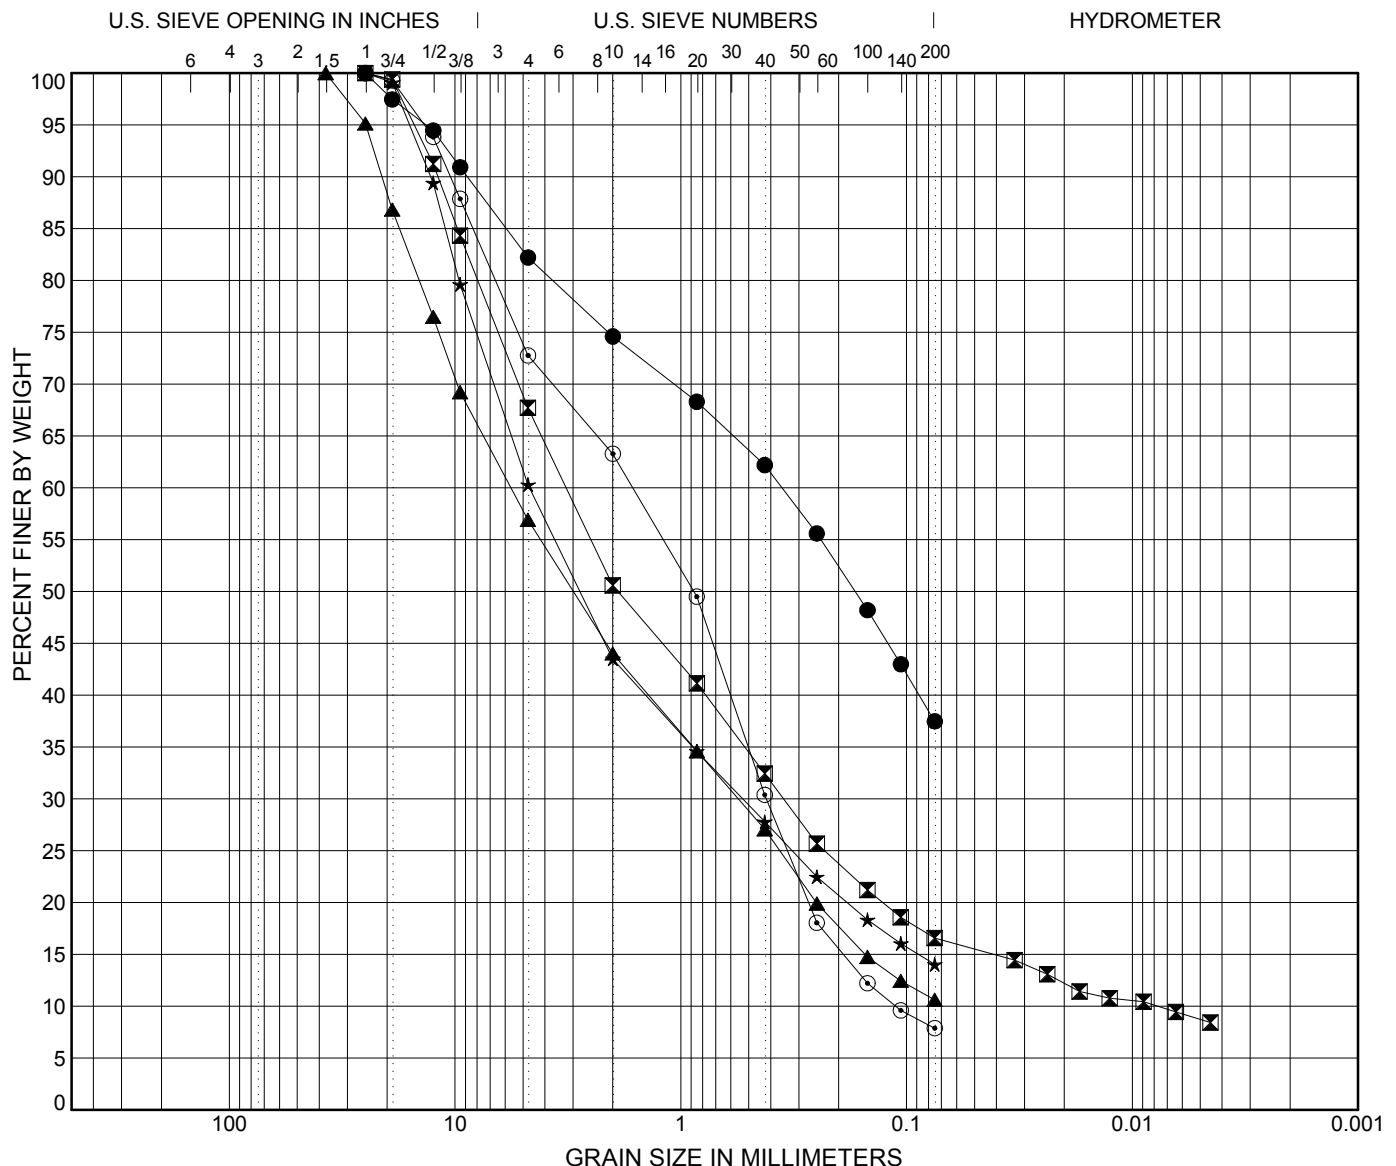
Sample Location	Sample Number	Depth (ft)	USCS Classification	Cc	Cu	% Gravel	% Sand	% Fines	% < 0.02 mm
●	BH-05	4	7.5	silty sand with gravel (SM)	-	-	18	45	37	
■	BH-07	1	0.0	silty sand with gravel (SM)	5.0	417.0	32	51	17	12
▲	BH-08	2	2.5	poorly graded sand with silt and gravel (SP-SM)	0.8	84.8	43	46	11	
★	BH-09	1	0.0	silty sand with gravel (SM)	-	-	40	46	14	
○	BH-11	1	0.0	poorly graded sand with silt and gravel (SP-SM)	1.0	14.6	27	65	8

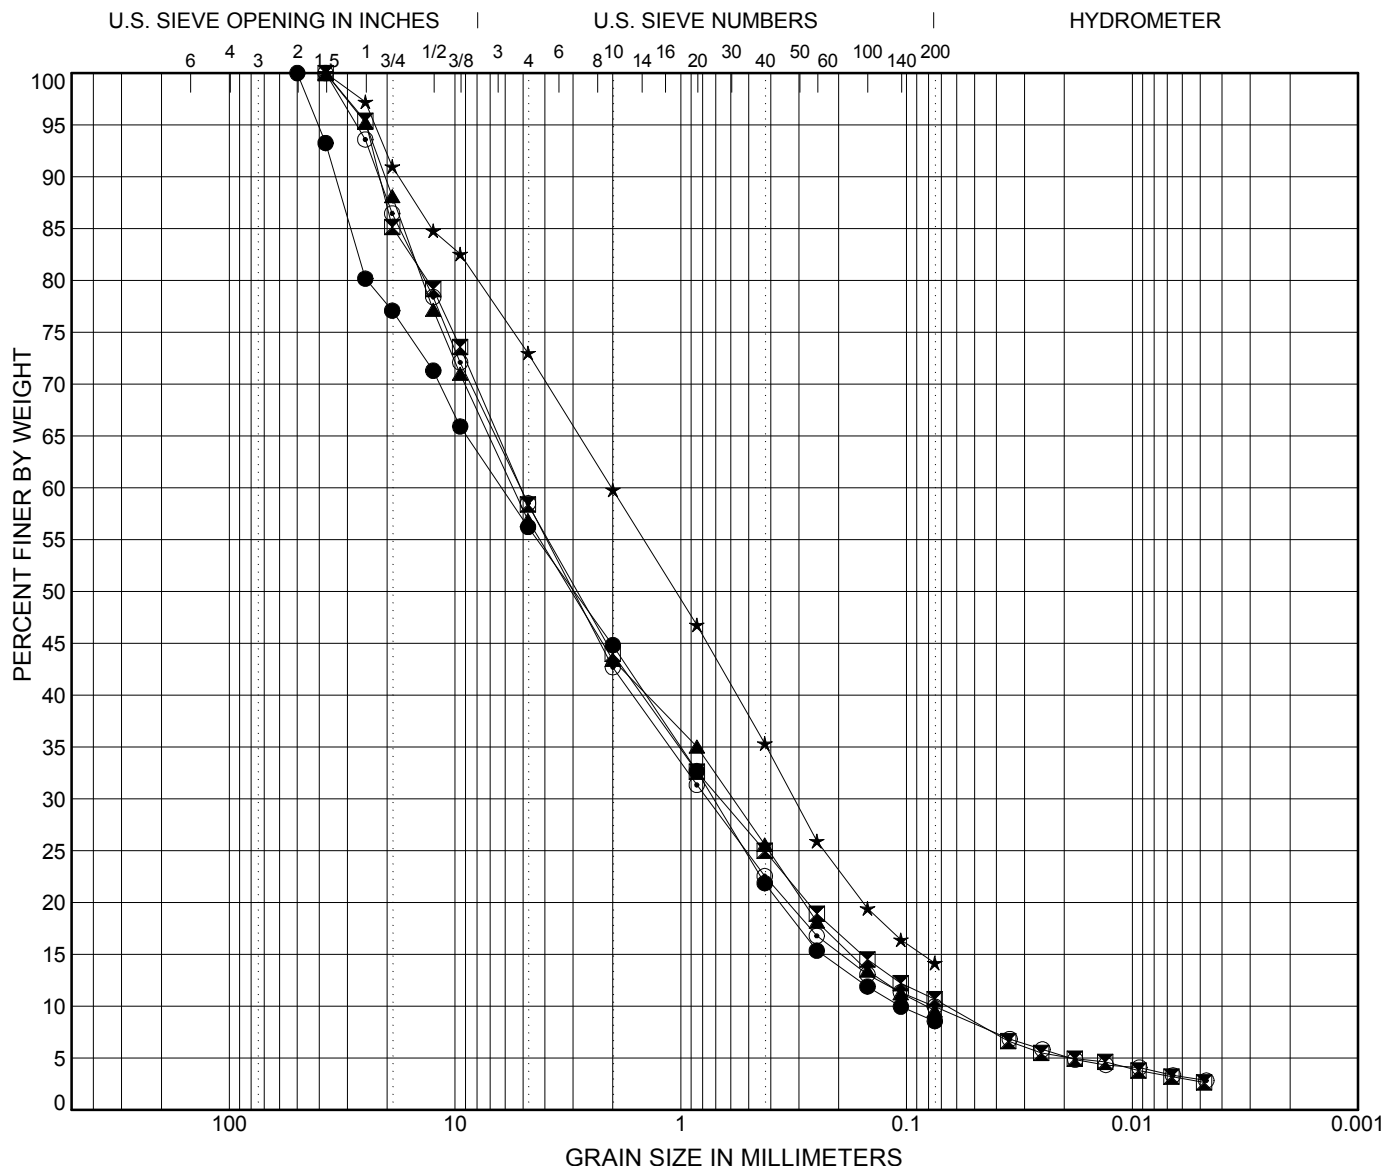
Sample Location	Sample Number	Depth (ft)	USCS Classification	Cc	Cu	% Gravel	% Sand	% Fines	% < 0.02 mm
●	BH-11	3	5.0	poorly graded sand with silt and gravel (SP-SM)	0.8	58.3	44	48	9	
⊠	BH-13	2	2.5	well-graded sand with silt and gravel (SW-SM)	1.3	77.1	42	48	11	5
▲	BH-14	1	0.0	poorly graded sand with silt and gravel (SP-SM)	0.8	67.8	43	47	10	
★	BH-14	3	5.0	silty sand with gravel (SM)	-	-	27	59	14	
⊙	BH-15	2	2.5	well-graded sand with silt and gravel (SW-SM)	1.5	67.7	41	49	10	5

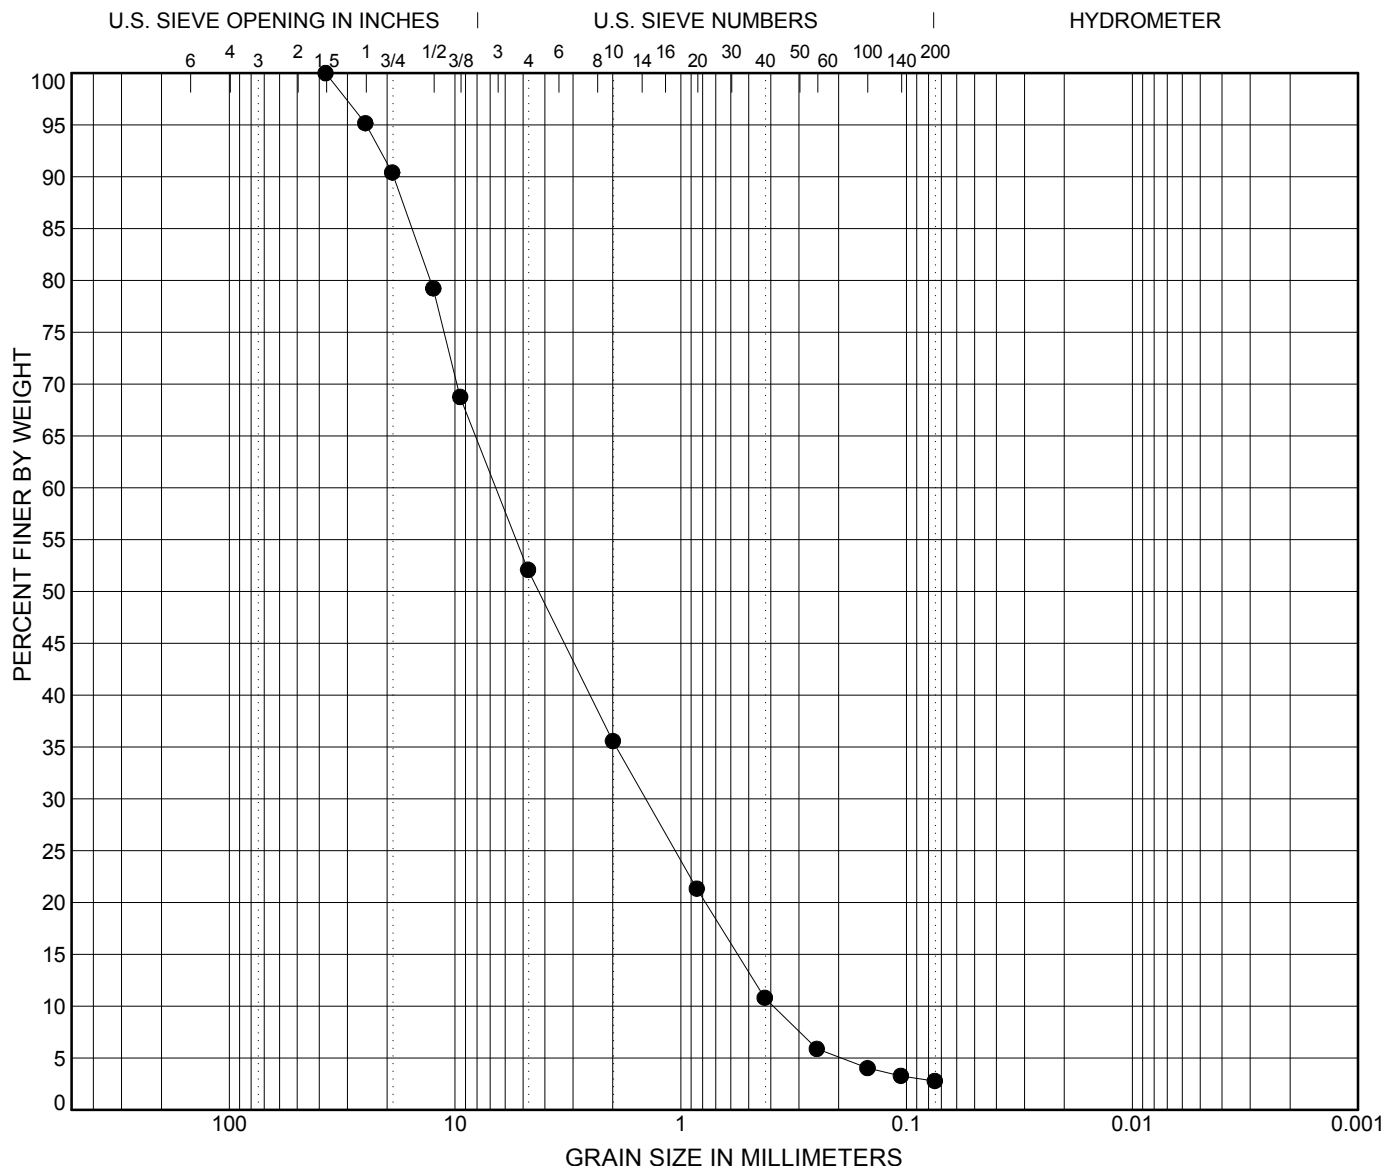
Sample Location	Sample Number	Depth (ft)	USCS Classification	Cc	Cu	% Gravel	% Sand	% Fines	% < 0.02 mm
●	BH-15	4	7.5	poorly graded sand with gravel (SP)	0.8	17.0	48	49	3

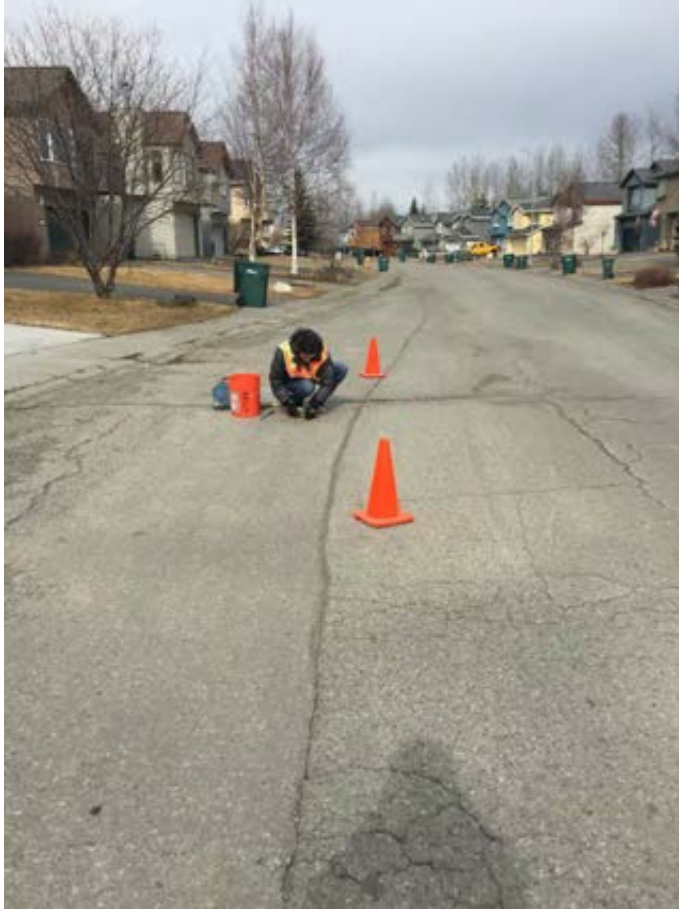
**Project Title: Image/Reflection Drive Road Upgrades****PHOTO 1**

Typical pavement conditions along the project area, Photo taken at Borehole BH-03.

There are frequent pavement patches at manholes, indicative of movement of the manholes relative to the road surface, as well as periodic depressions along the curb and over the branch of Chester Creek culvert. In addition, the Portland cement concrete sidewalks are badly broken in many areas. The broken sidewalk is likely related to poor subgrade conditions or frost movement, which is exacerbated by vehicles that were seen parking on the sidewalks in some areas and any drainage from the lots that may concentrate water to the sidewalk areas.

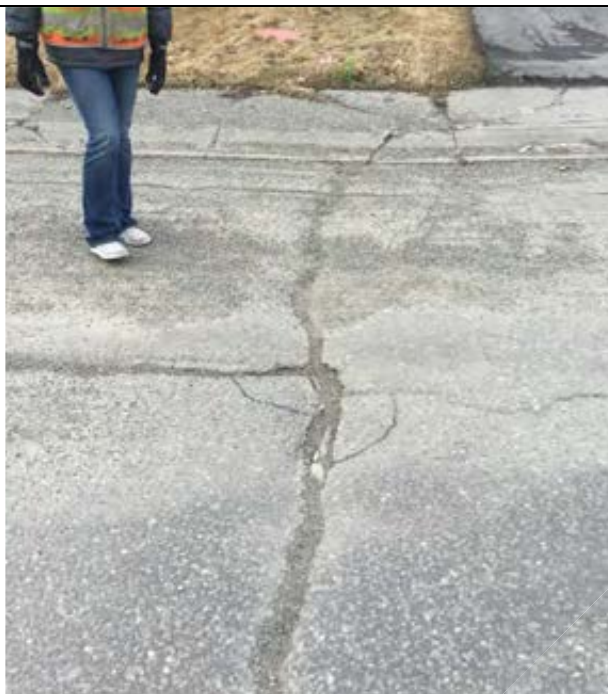
**PHOTO 2**

Typical pavement and sidewalk conditions along project area. Photo taken near Borehole BH-02.

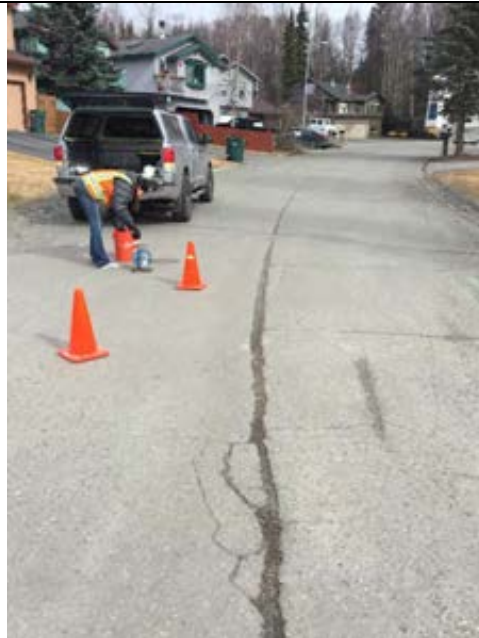
PHOTO 3

Cracking along road center line near Borehole BH-11.

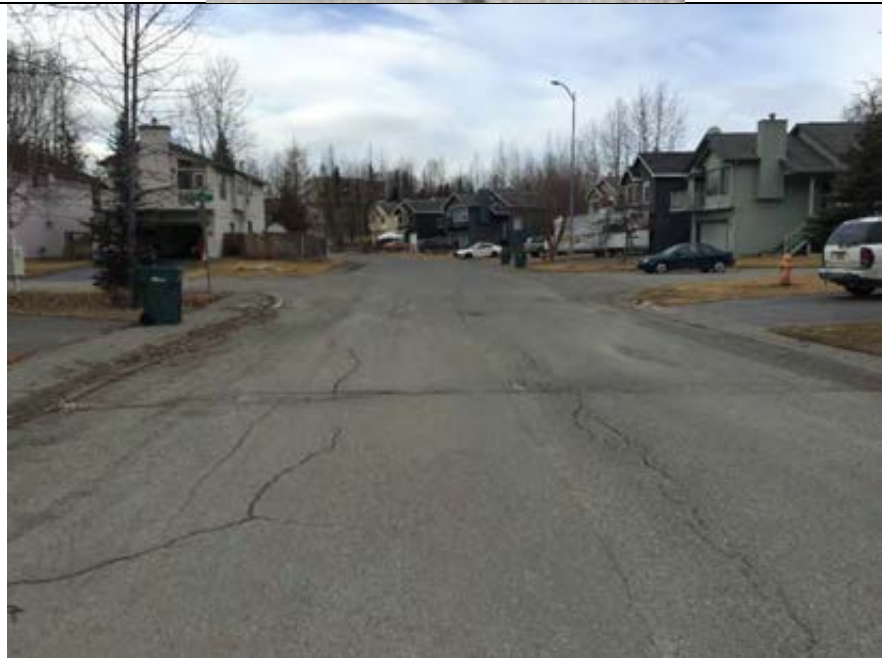
PHOTO 4

Typical pavement and sidewalk conditions along project area. Photo taken near Borehole BH-10.

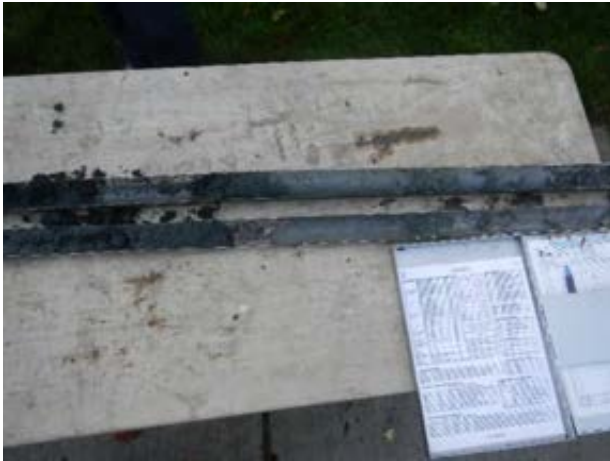
Photo 1: Typical geoprobe sampler liner.

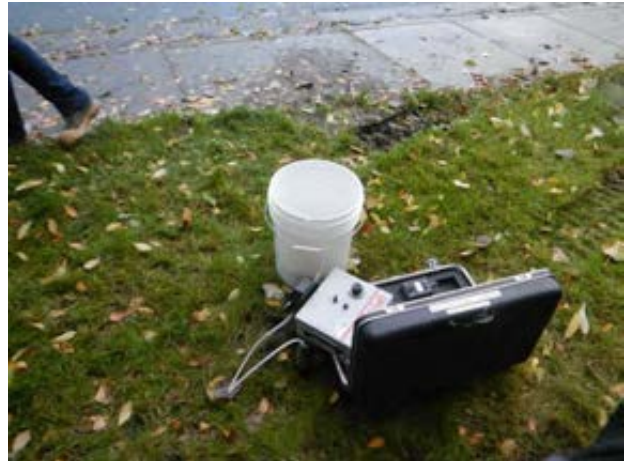
Photo 2: Purging temporary groundwater well point at DP-1

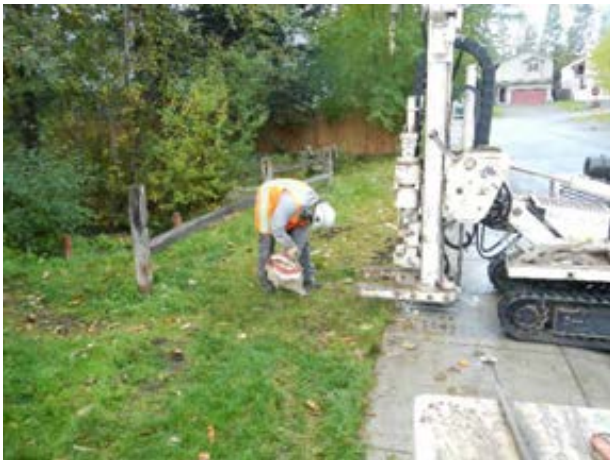
Photo 3: Backfilling DP-2 with bentonite chips

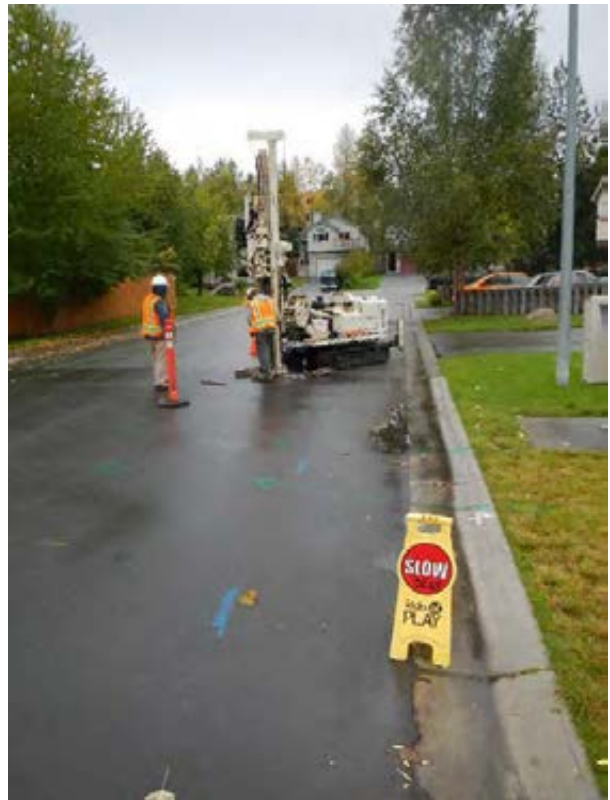
Photo 4: Drilling DP-5.

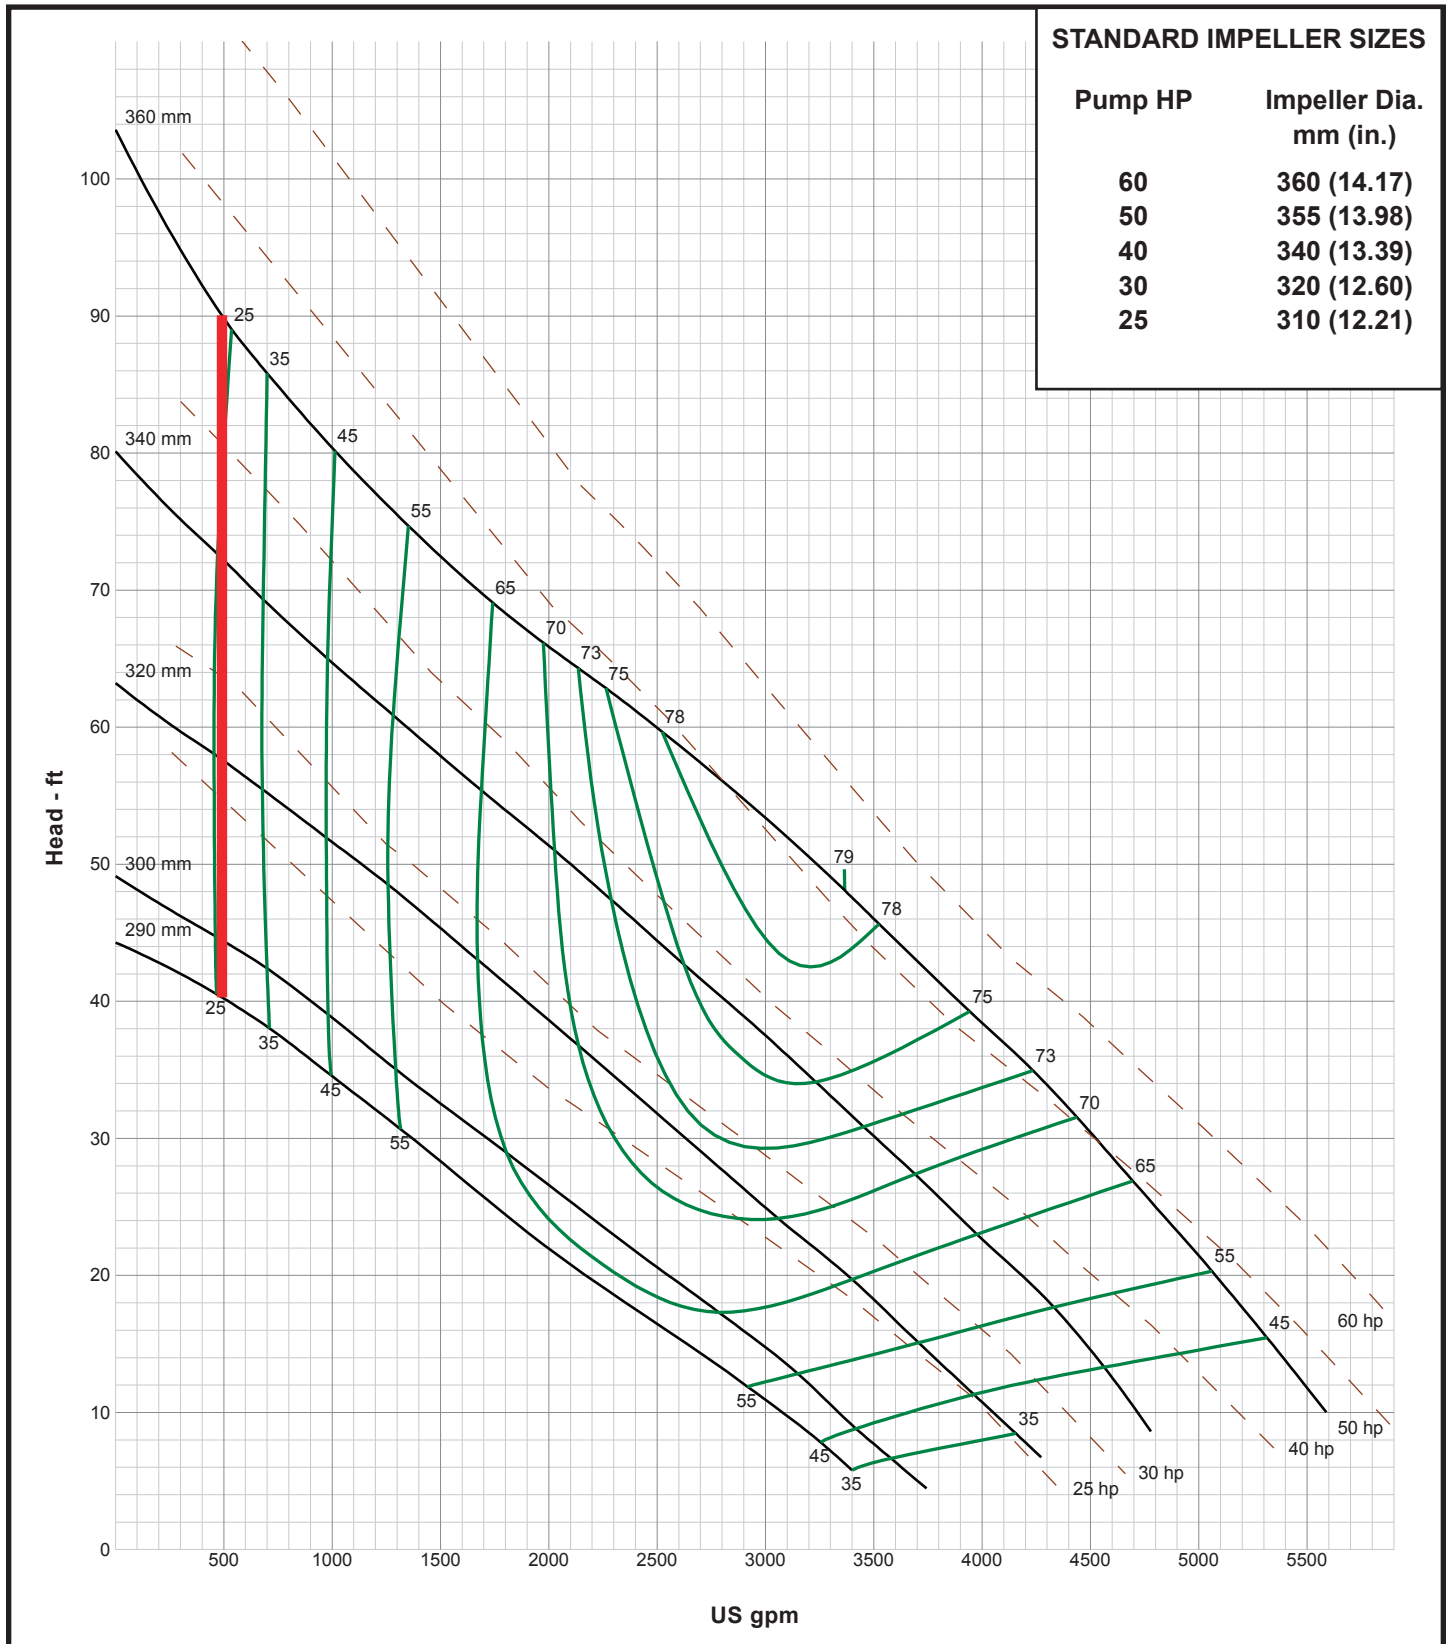
Series 10SHDW

Performance Curve
10 - 25HP, 870RPM, 60Hz

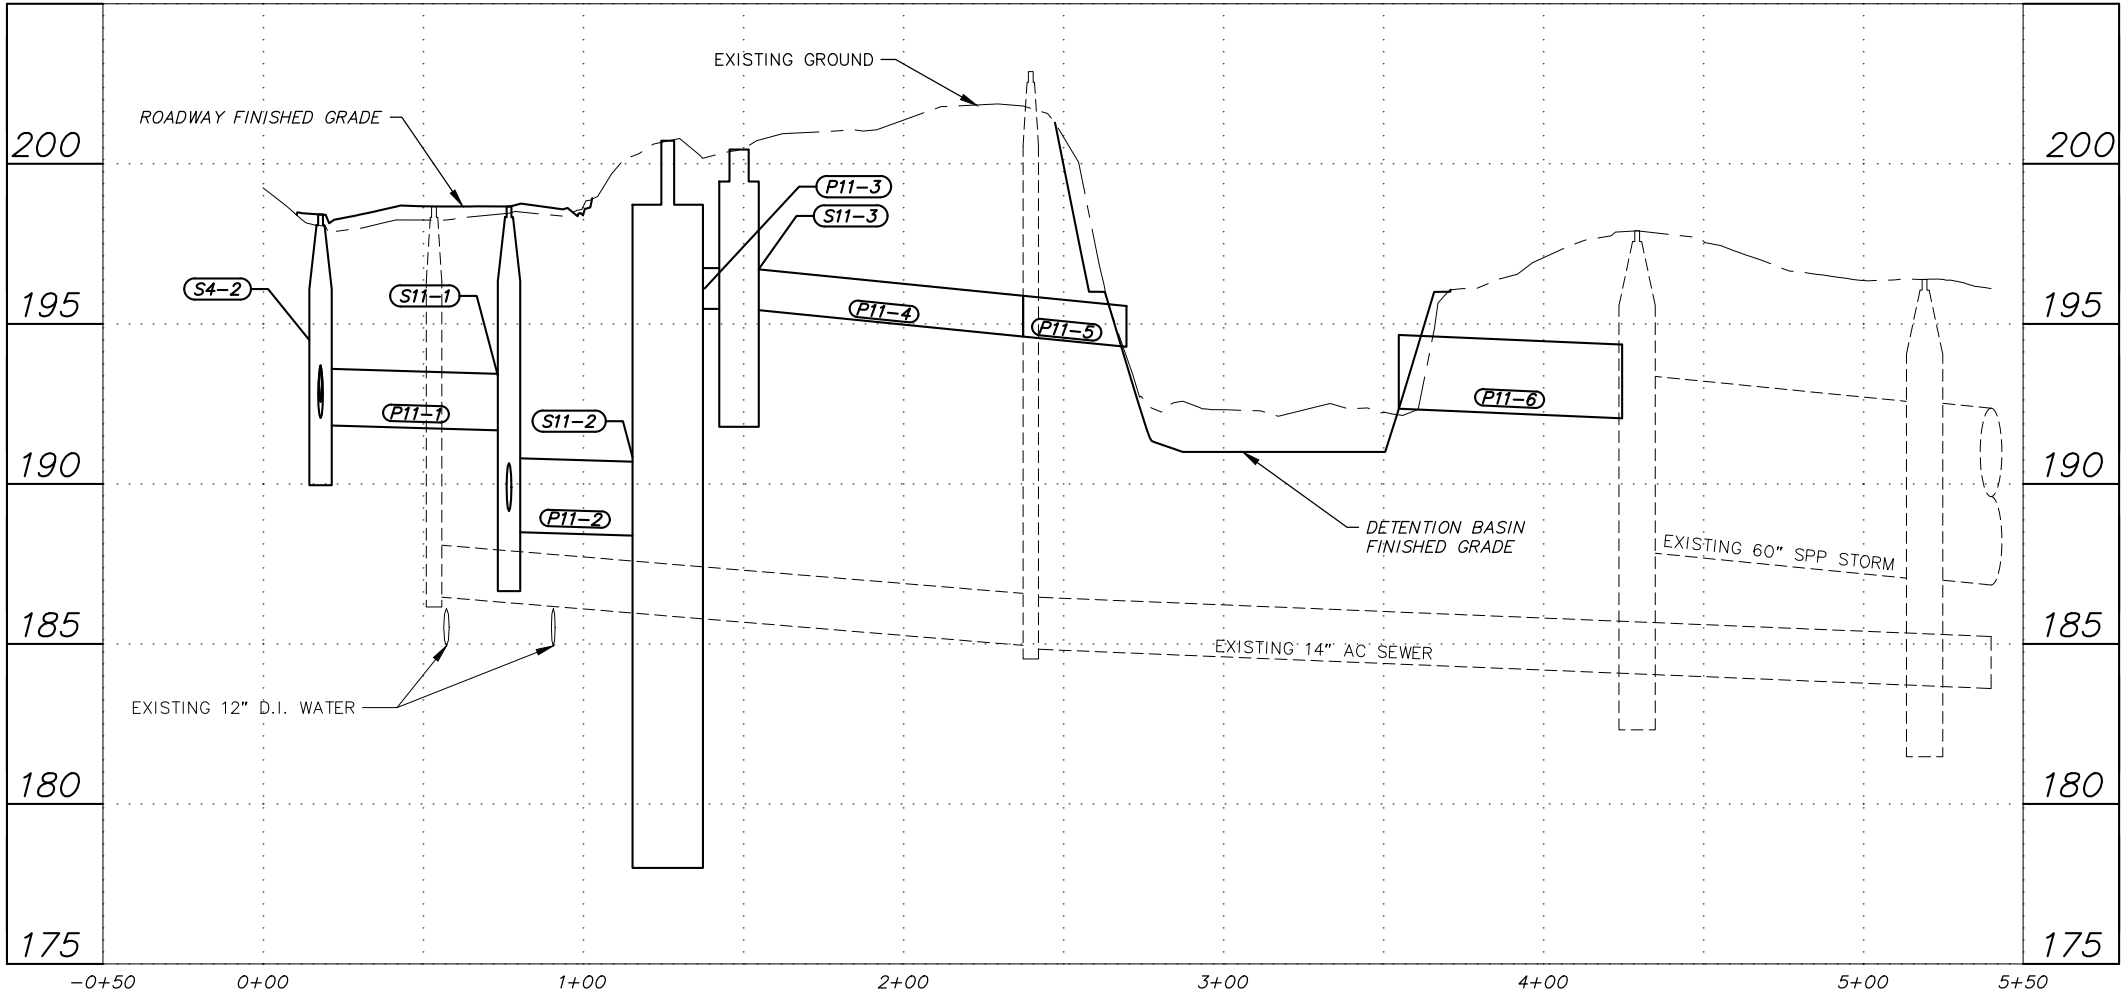
1. INSTALL HEAT TRACE ALONG DETENTION BASIN FLOOR AND OUTFALL PIPE P11-6.

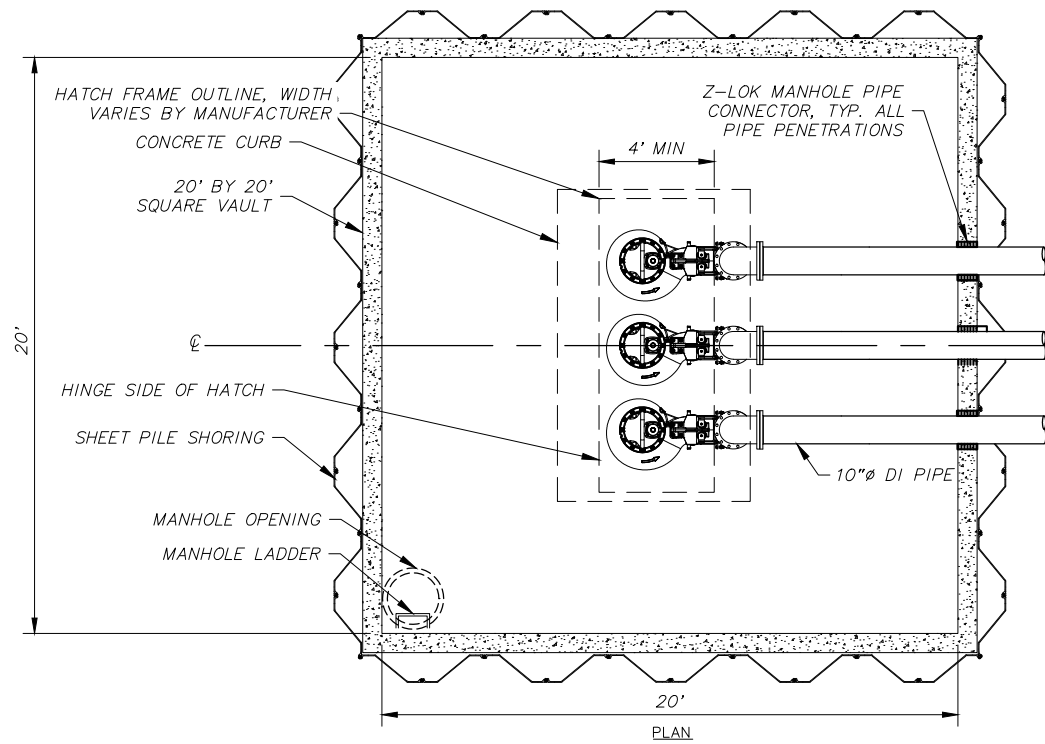
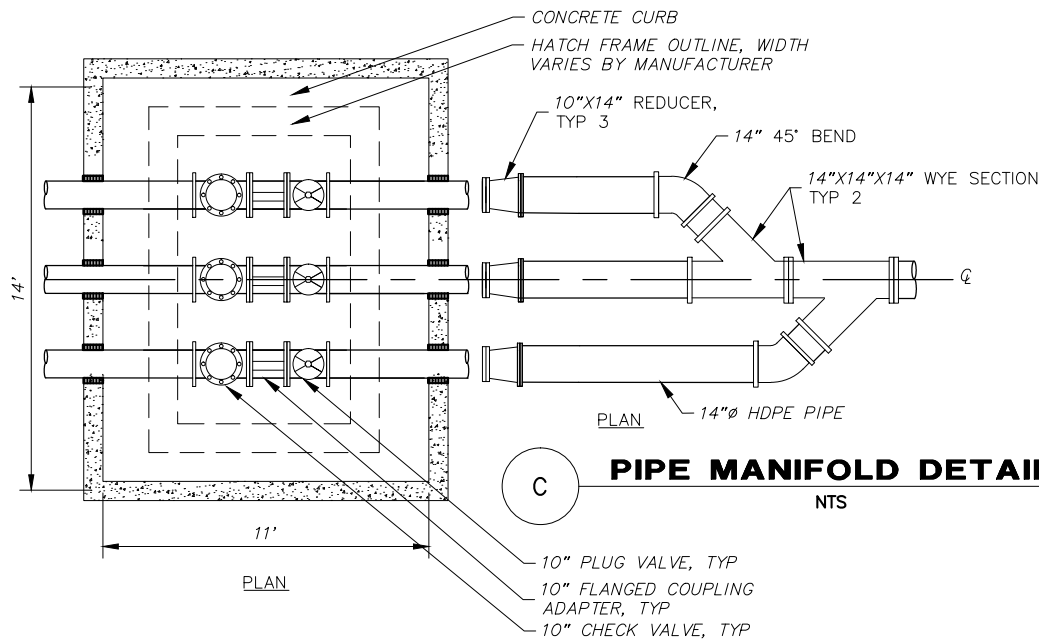
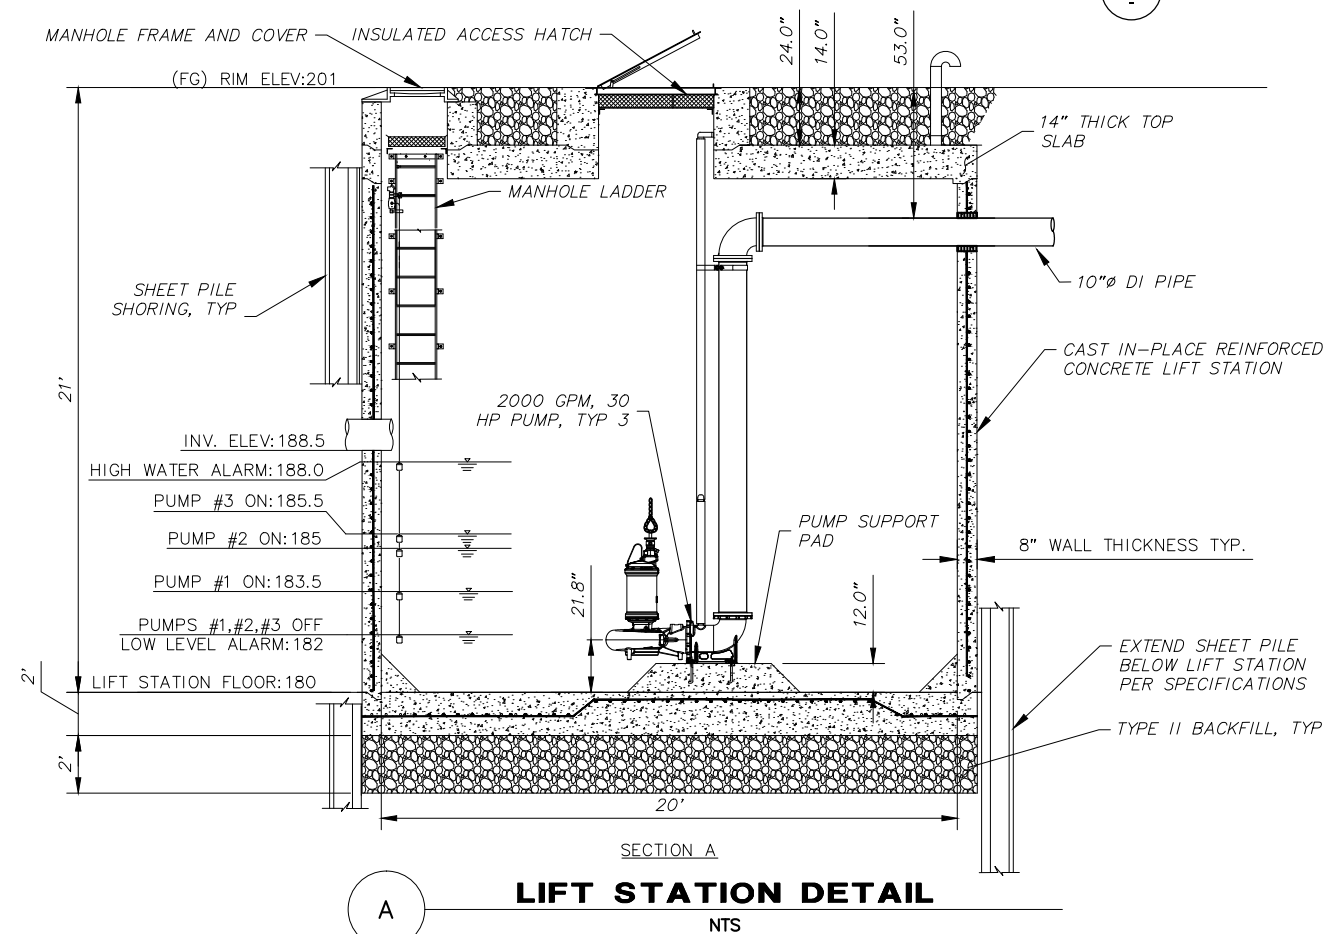
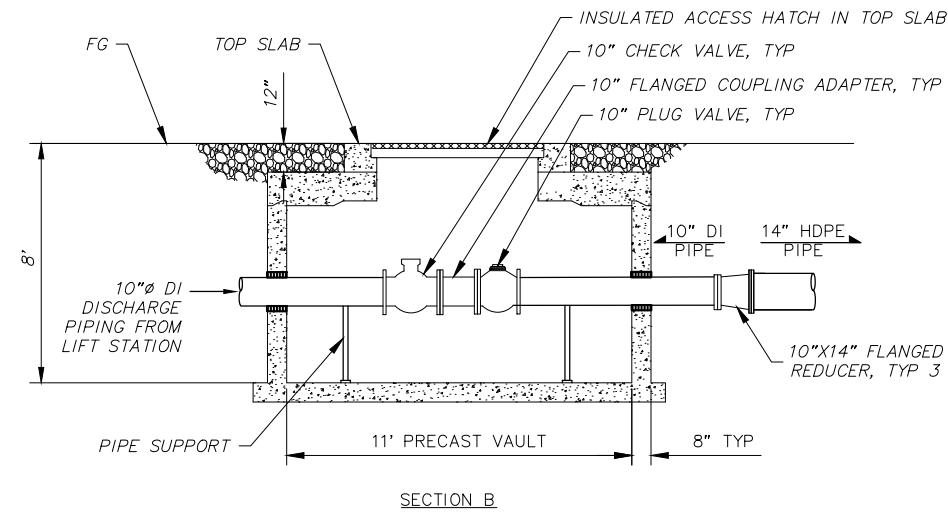
LIFT STATION DETAIL

VALVE VAULT DETAIL
