APPENDIX B

ESSENTIAL FISH HABITAT ASSESSMENT AND FISH SURVEYS

SUBJECT: Trip Report Shotgun Cove Road
August 2018

SUBJECT: Trip Report Shotgun Cove Road
October 2018

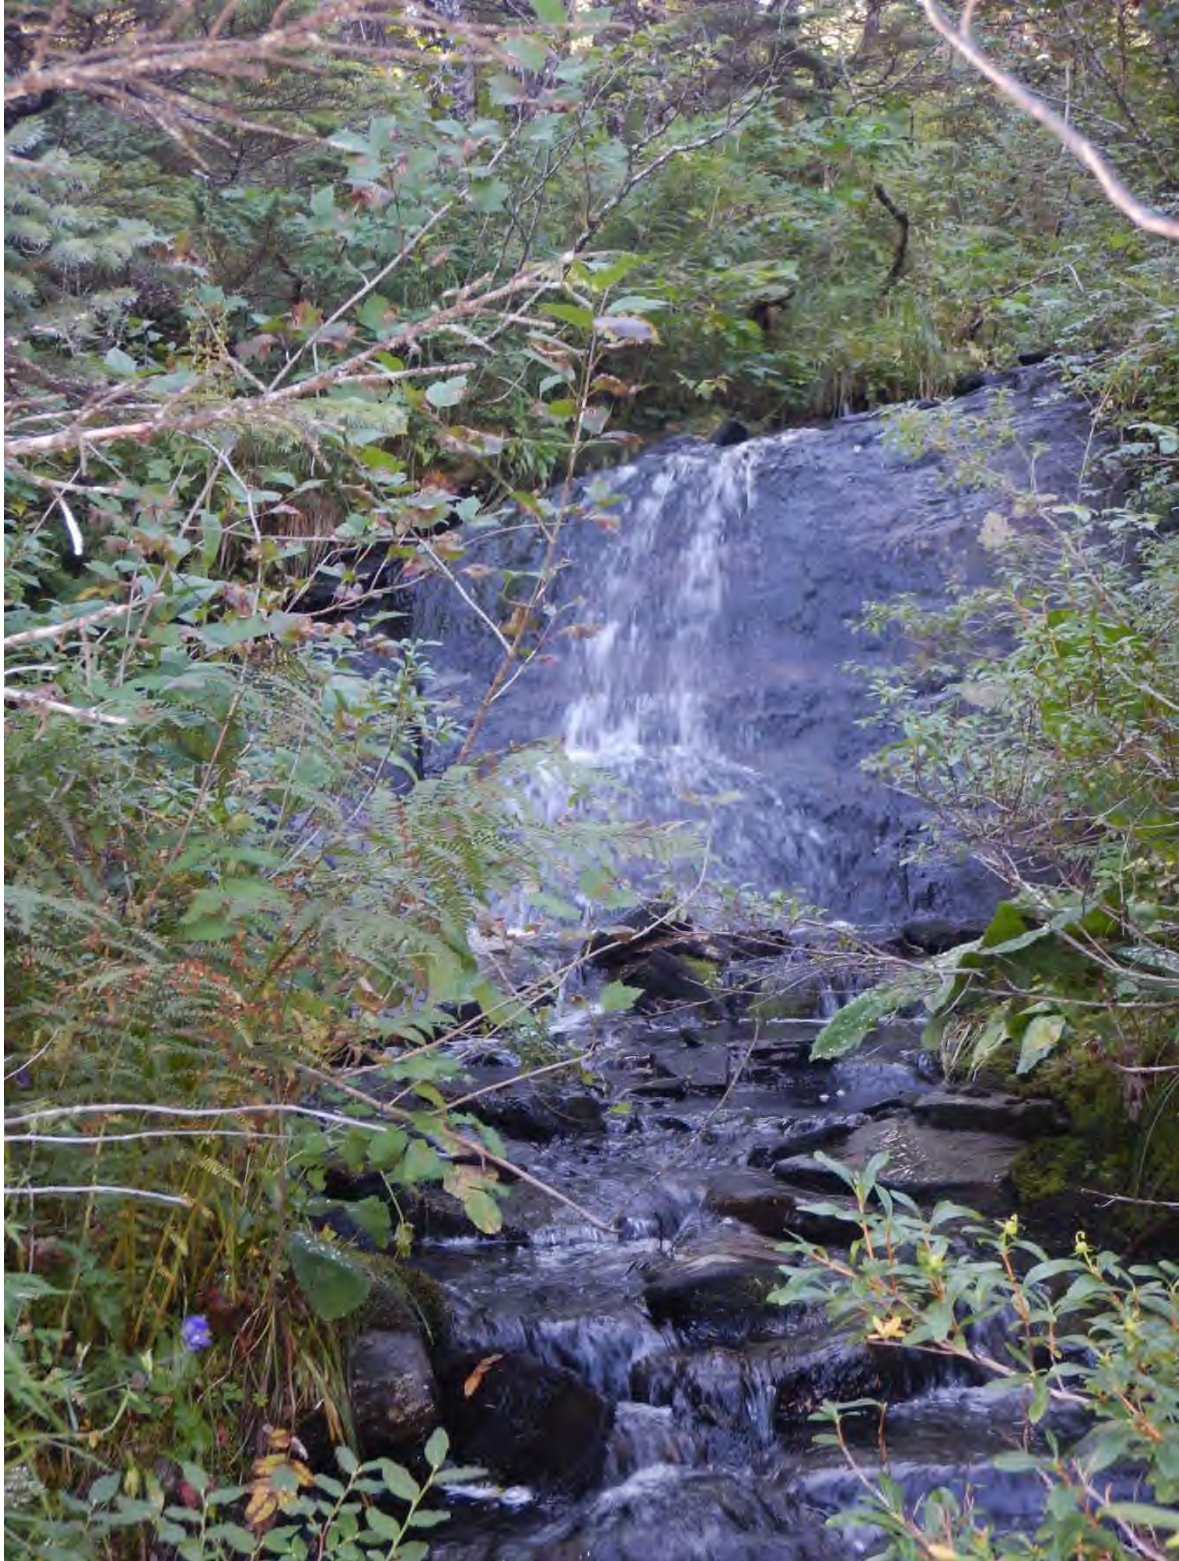
Figure 1. Stream #1 barrier.

Stream #1 was located at 60.787 N, 148.623 W. We located a 7 foot high barrier about 30 meters upstream of tidewater (Figure 1). We set a baited minnow trap about 75 meters upstream of the barrier in meadow habitat (Figure 2). The trap soaked about 5 hours and no fish were captured or observed in the stream. The road crossing structure will not be required to provide fish passage.

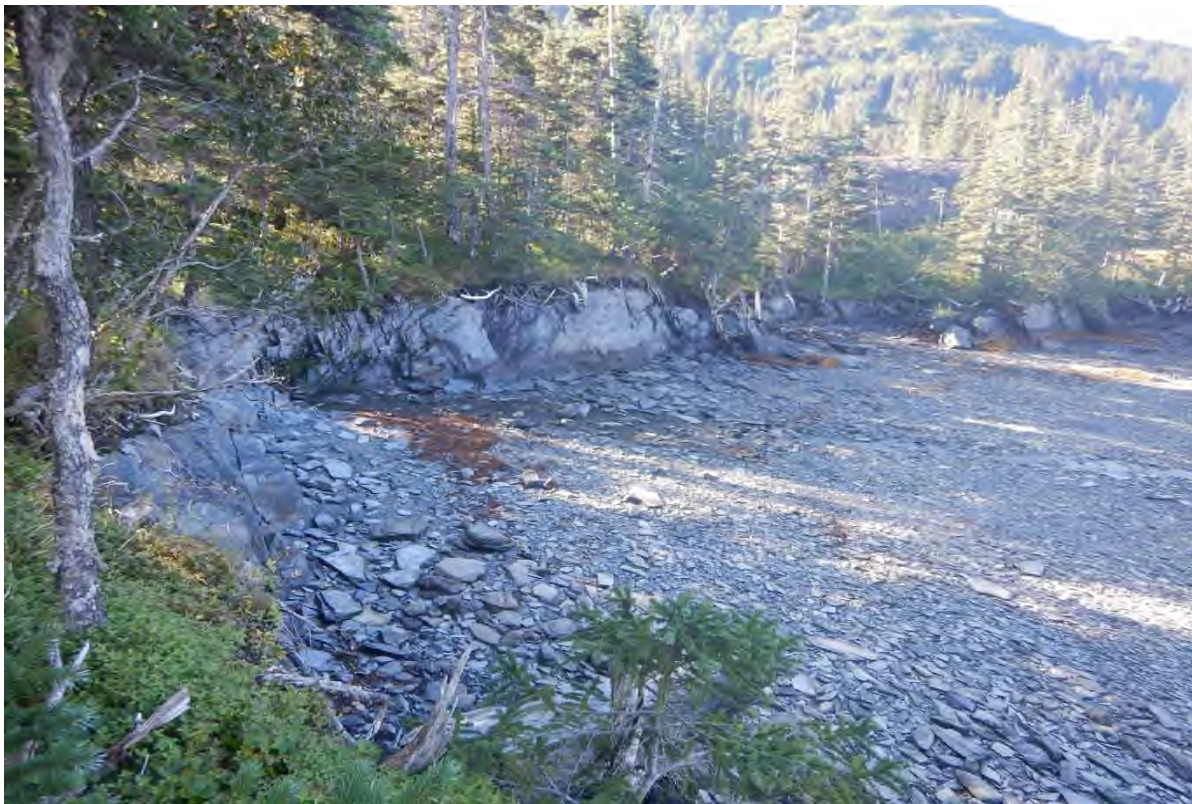
Figure 3. Stream #2 beach.

Stream #2 was located at 60.788 N, 148.622 W. We walked downstream to tidewater and observed the streamflow became subsurface at the beach (Figure 3). About 150 meters upstream of the beach we observed a gradient barrier to fish passage (Figure 4). No salmonids were observed. The road crossing structure will not be required to provide fish passage.

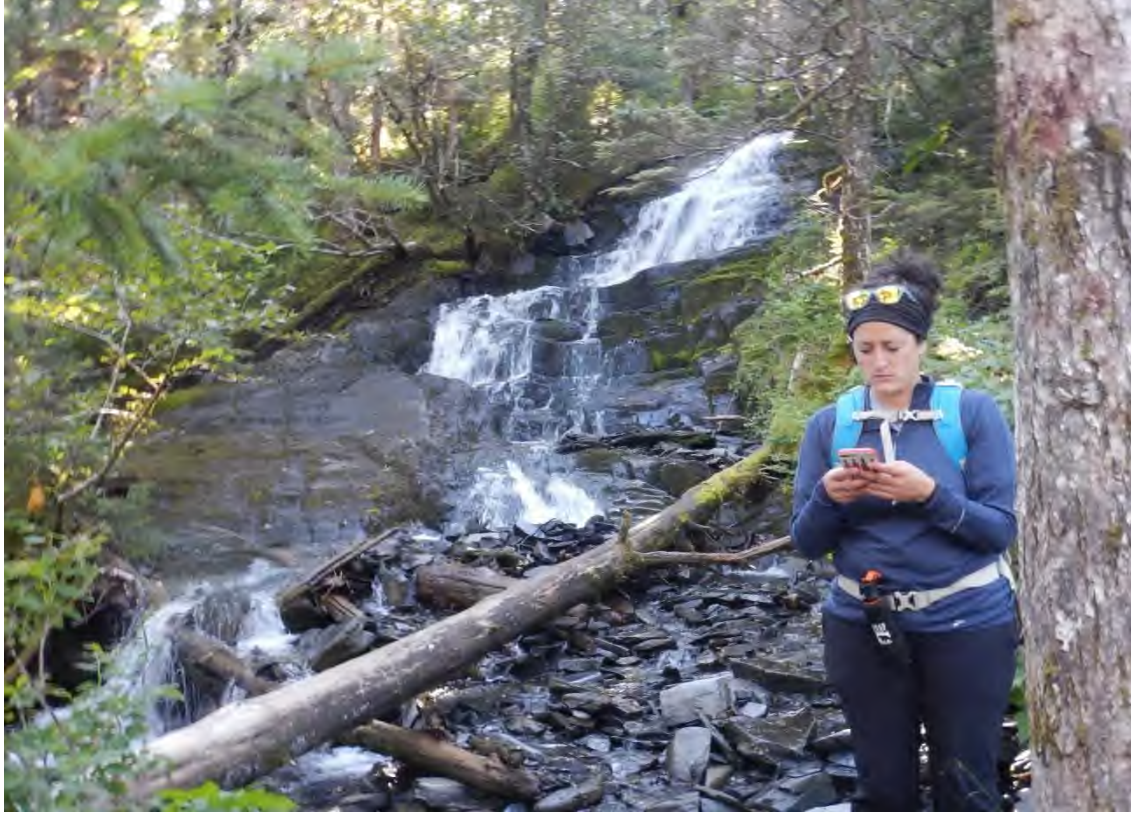
Figure 5. Stream #4 barrier.

Stream #4 was located at 60.790 N, 148.614 W. We set a baited minnow trap directly downstream of a 30 foot high barrier (Figure 5). The trap soaked about 5 hours and no fish were captured or observed in the stream in the upper reach near the barrier. We walked downstream to tidewater and observed about 35 recently spawned pink salmon (Figures 6 through 8). About 100 meters upstream from tidewater we observed a gradient barrier. The ADF&G requests to sample the stream upstream of the 30 foot barrier in the area of the proposed road crossings to determine if resident salmonids are present in the project area. The unnamed stream downstream of the gradient barrier will be nominated to the Anadromous Waters Catalog.

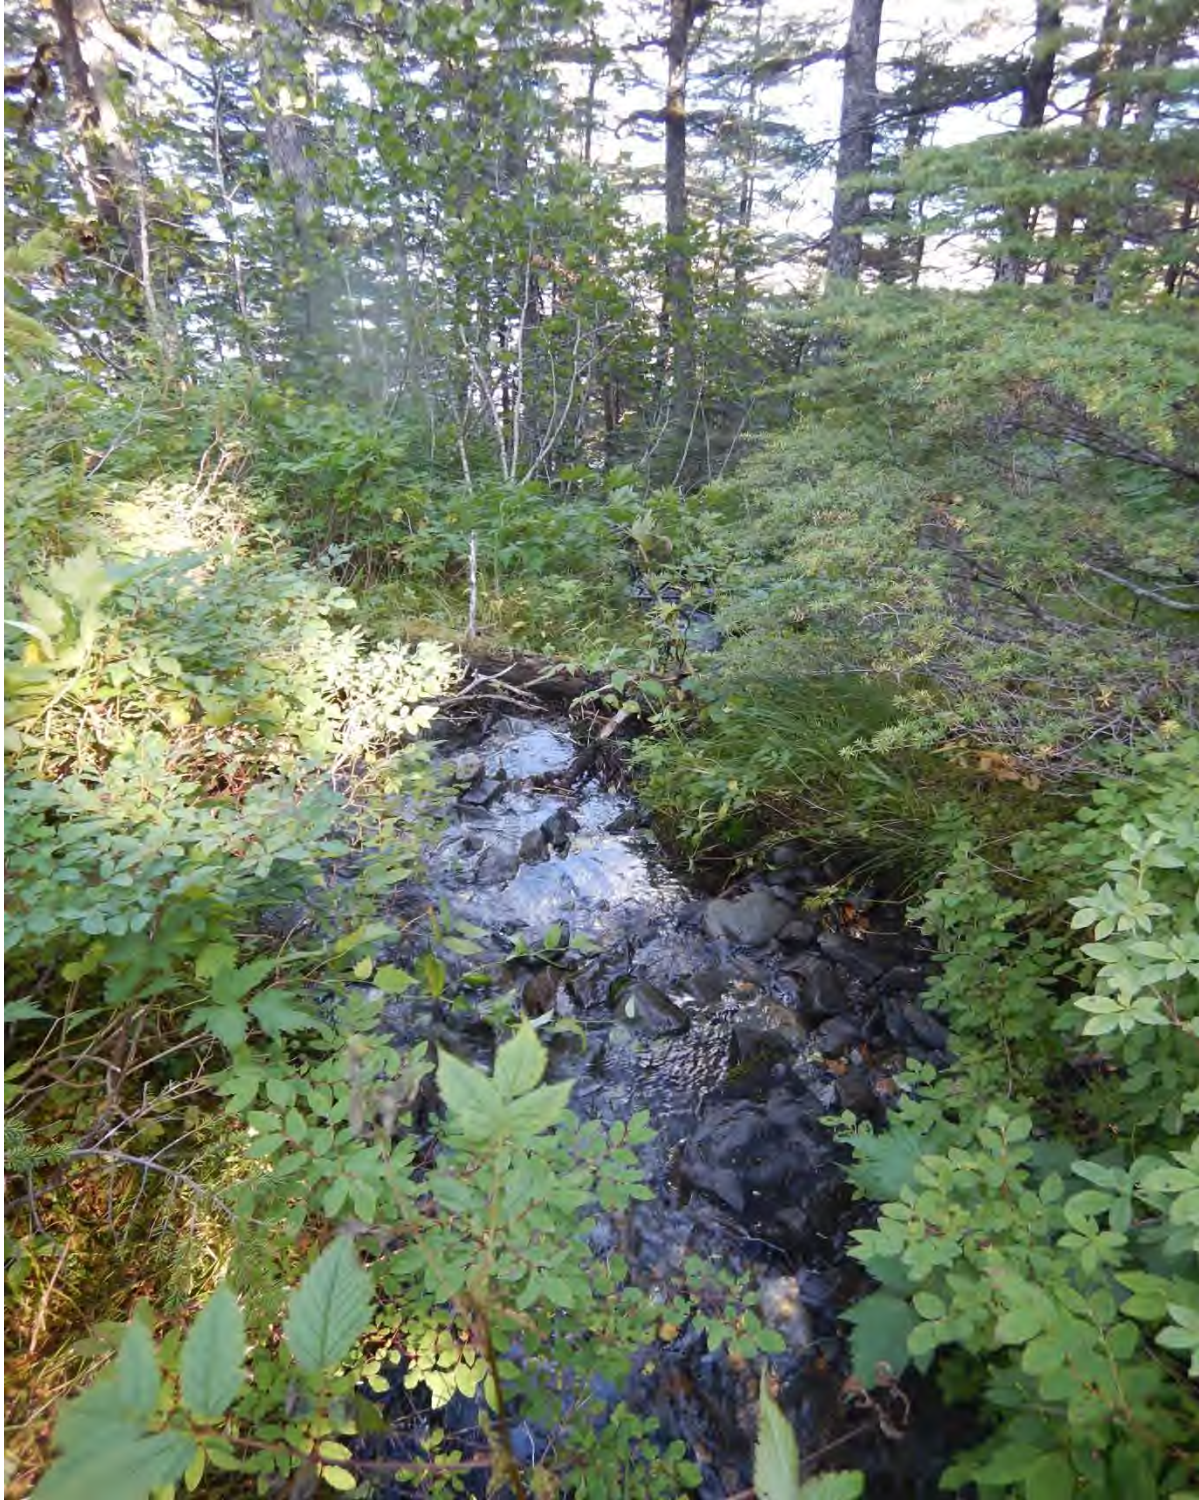
Stream #5 was located at 60.792 N, 148.609 W. The stream channel slope was over 25% and unlikely to support fish. The stream flowed over a cliff to tidewater (Figure 9). The road crossing structure will not be required to provide fish passage.

Figure 9. Stream #5 flowing over cliff to Passage Canal. View looking downstream.

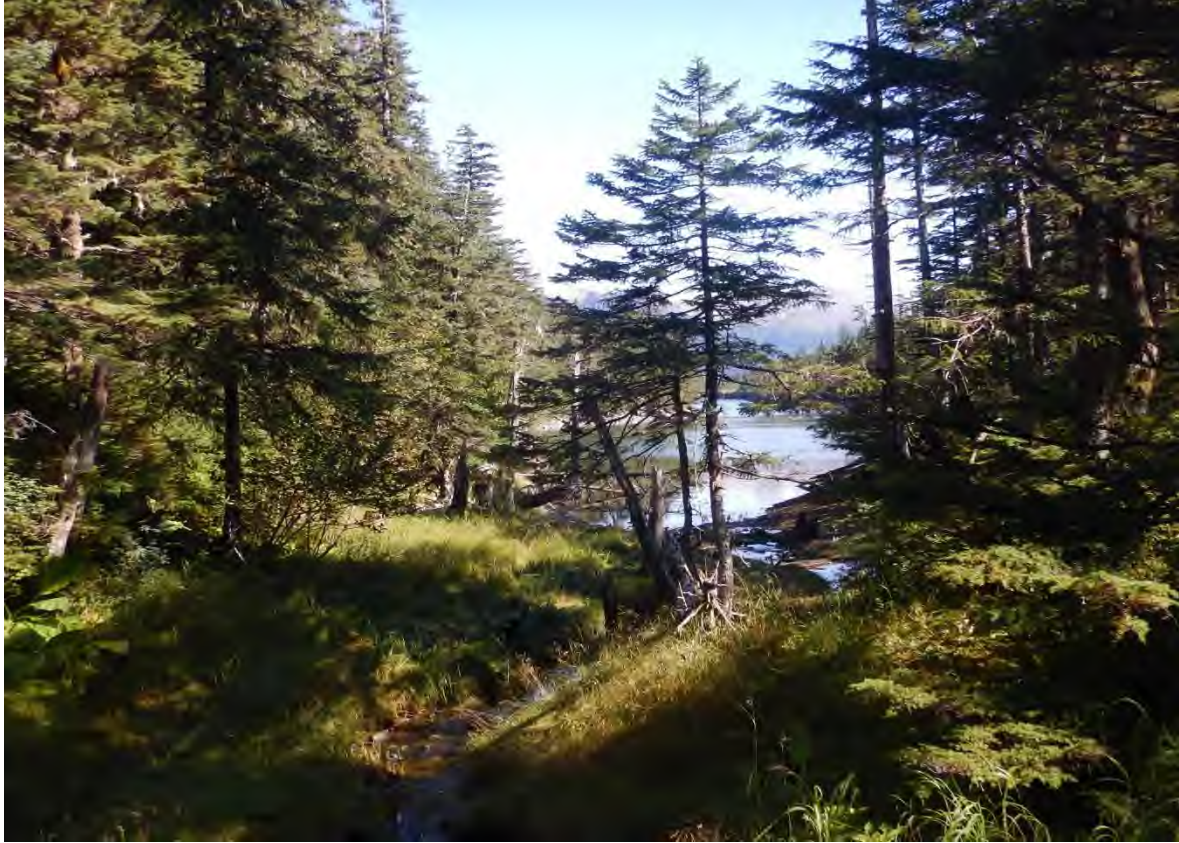
Stream #10 was located at 60.800 N, 148.583 W. We set one baited minnow trap about 50 meters upstream of tidewater (Figure 12). The trap soaked about 2 hours and no fish were captured or observed in the stream. The ADF&G requests to sample the stream upstream in the area of the proposed road crossings to determine if resident salmonids are present in the project area.

Figure 12. Stream #10, view looking downstream.

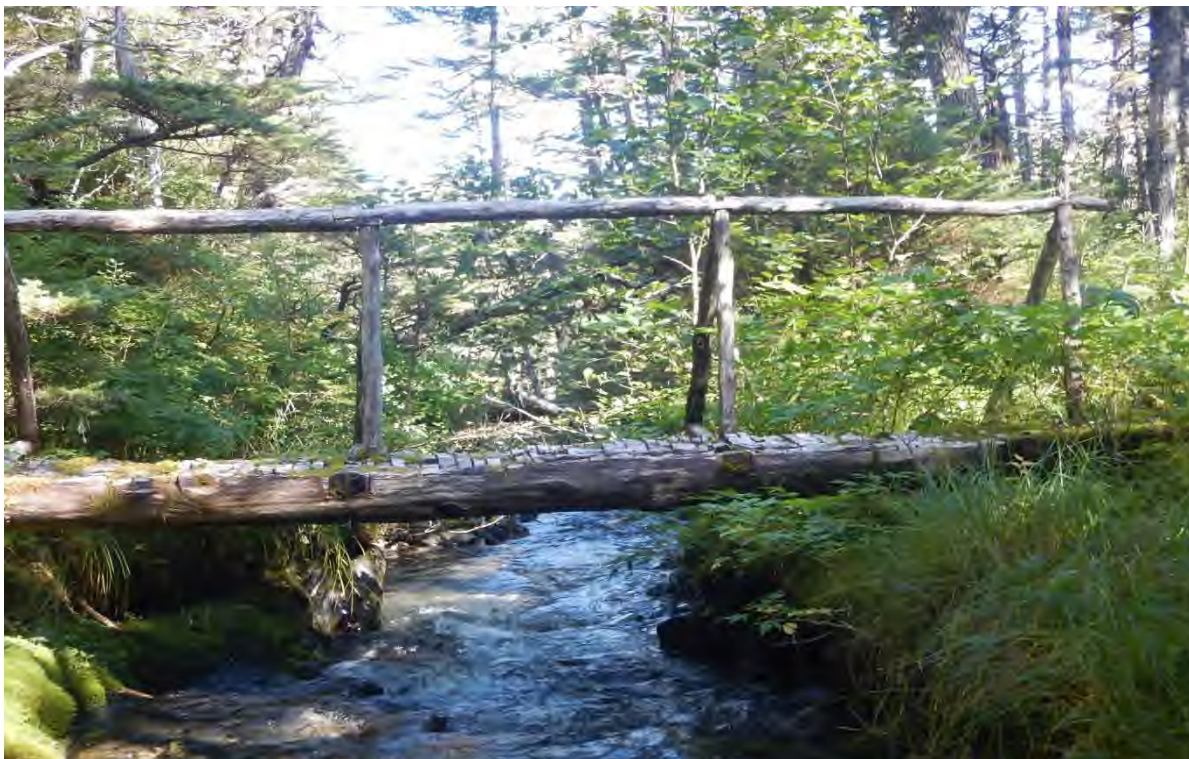
Stream #11 (Stream No. 224-10-14430) was located at 60.801 N, 148.578 W (Figure 13). The stream flows into Emerald Bay. We located a 40 foot high barrier directly downstream of the trail crossing about 100 meters upstream of tidewater (Figure 14). The ADF&G requests to sample the stream upstream of the barrier in the area of the proposed road crossings to determine if resident salmonids are present in the project area. The upper extent of the specified reach will be updated to the Anadromous Waters Catalog.

Figure 13. Stream #11 foot bridge upstream of barrier.

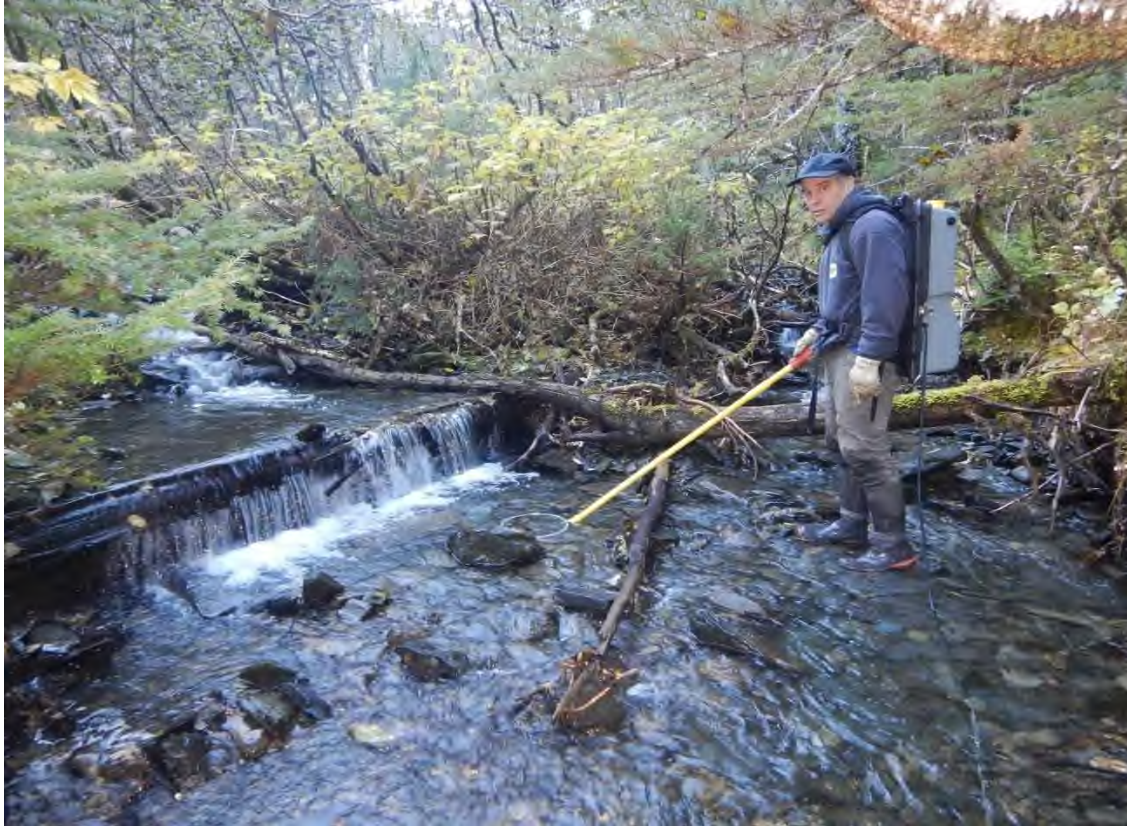
Stream #1 We began sampling using an electrofisher about 200 meters upstream of the specified reach of Steam No. 224-10-14430. The stream flows into Emerald Bay. We sampled 420 meters upstream of a 12-meter high barrier near the location of the proposed low road crossing at 60.800 N, 148.580 W (Figure 1). We captured or observed about 15 Dolly Varden (Figure 2). The proposed road crossing will require a bridge or culvert designed for fish passage.

Figure 1. Mr. Frost sampling upstream of the specified reach of Steam No. 224-10-14430.

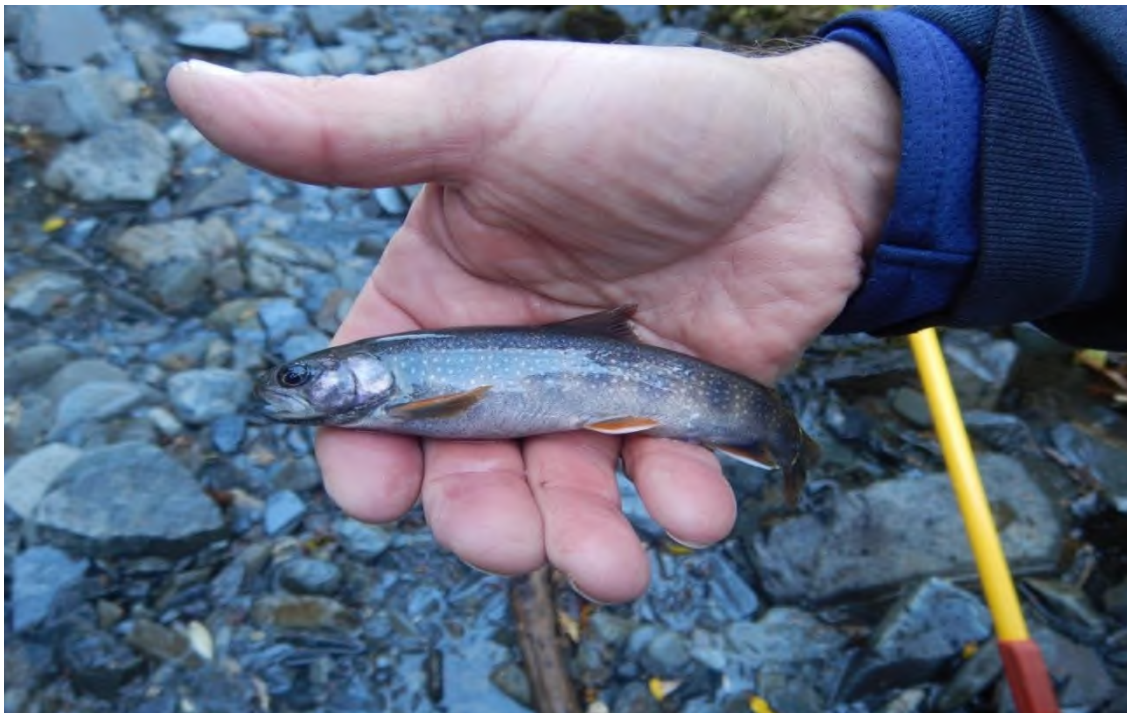
Figure 2. Dolly Varden captured upstream of the specified reach of Steam No. 224-10-14430.

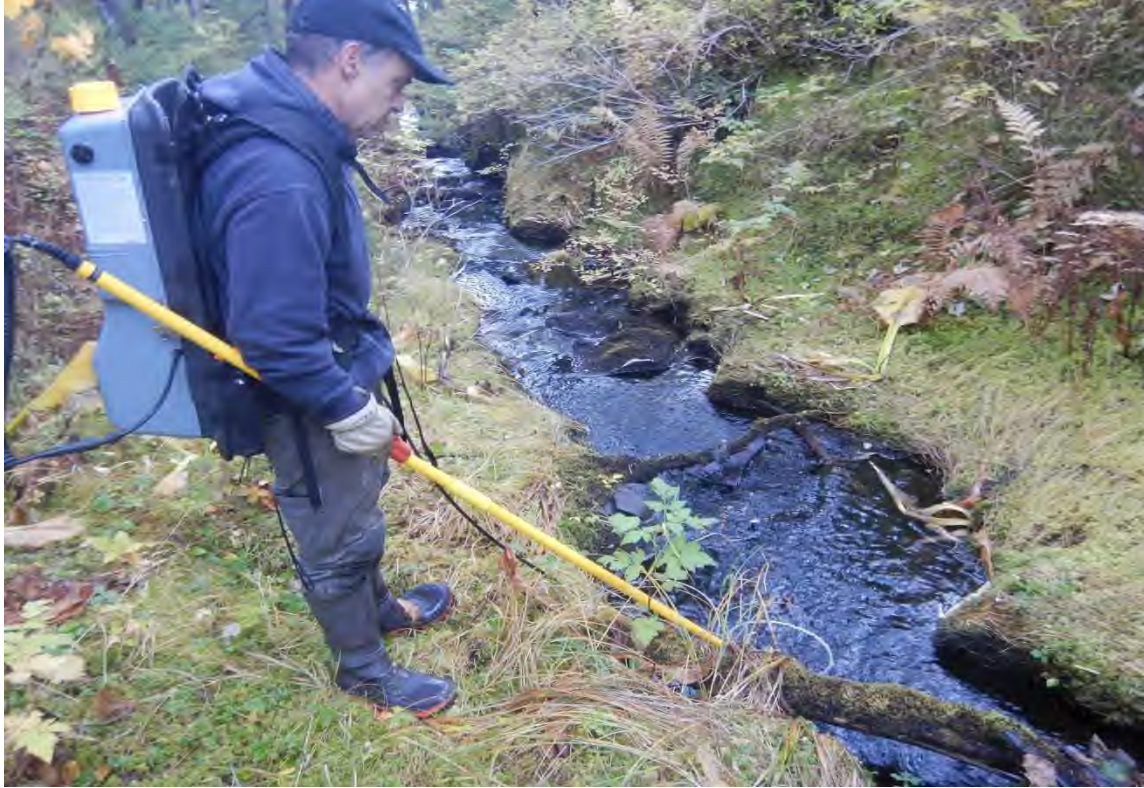
Stream #2 is located at 60.800 N, 148.585 W. We sampled upstream 200 meters from tidewater (Figure 3). The stream flows into Emerald Bay. We captured 5 Dolly Varden and 4 sculpin. The proposed road crossing will require a bridge or culvert designed for fish passage.

Figure 3. Sampling unnamed stream flowing into Emerald Bay.

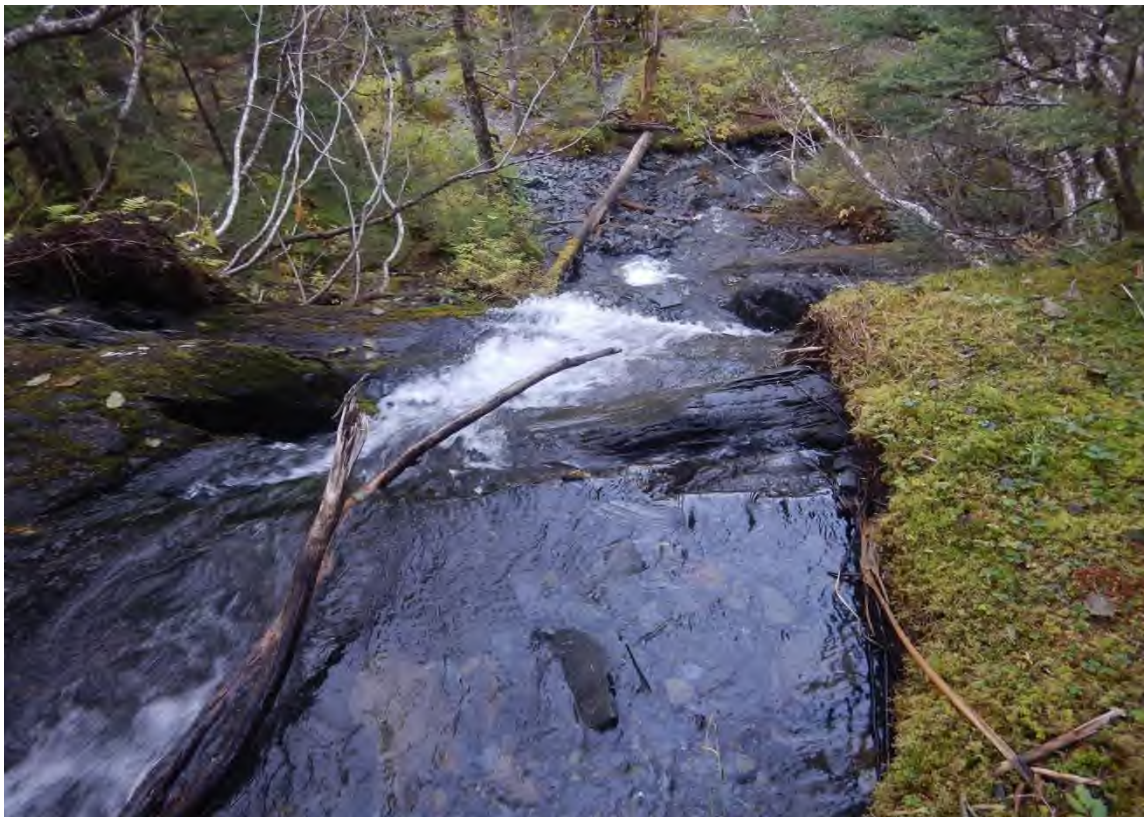
Stream #3 is located at 60.790 N, 148.613 W. We sampled 90 meters upstream from the 9-meter high barrier to the proposed high road crossing (Figures 4 and 5). The stream flows into Passage Canal. The stream gradient was >25%. No salmonids were captured or observed. We walked downstream to a gradient barrier located adjacent to tidewater. Adult pink salmon were

Figure 4. Nine meter high barrier. View looking downstream.

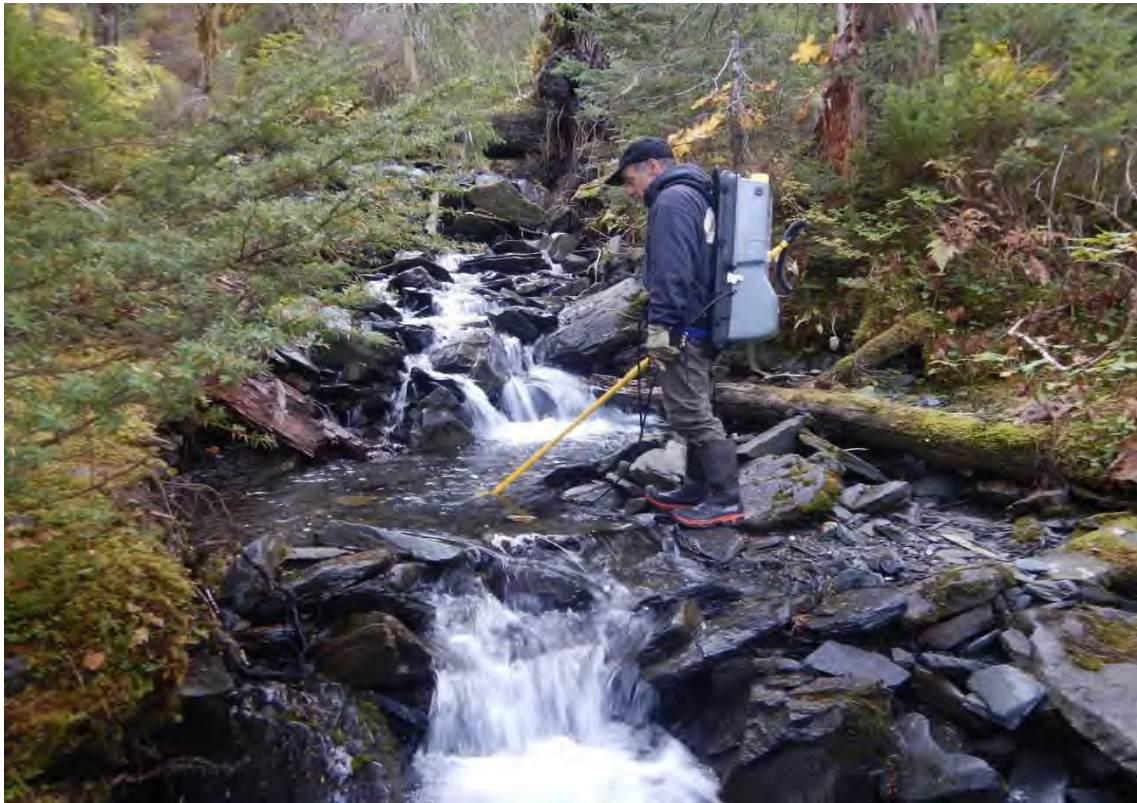
Figure 5. Sampling upstream of the nine meter high barrier.

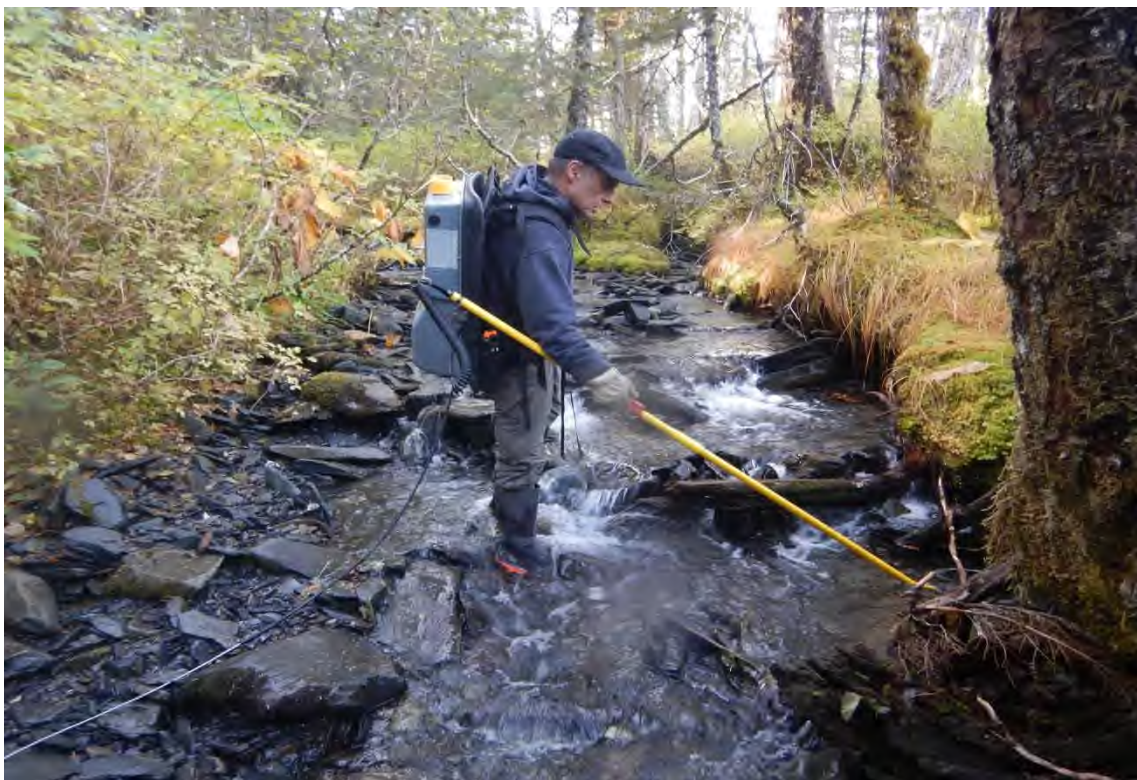
observed below the gradient barrier during the August 2018 fish survey. We sampled upstream 115 meters to the 9-meter high barrier (Figure 6). No salmonids were captured or observed between the two barriers. The proposed road crossing will not require a bridge or culvert designed for fish passage.

Figure 6. Sampling below the nine meter high barrier.

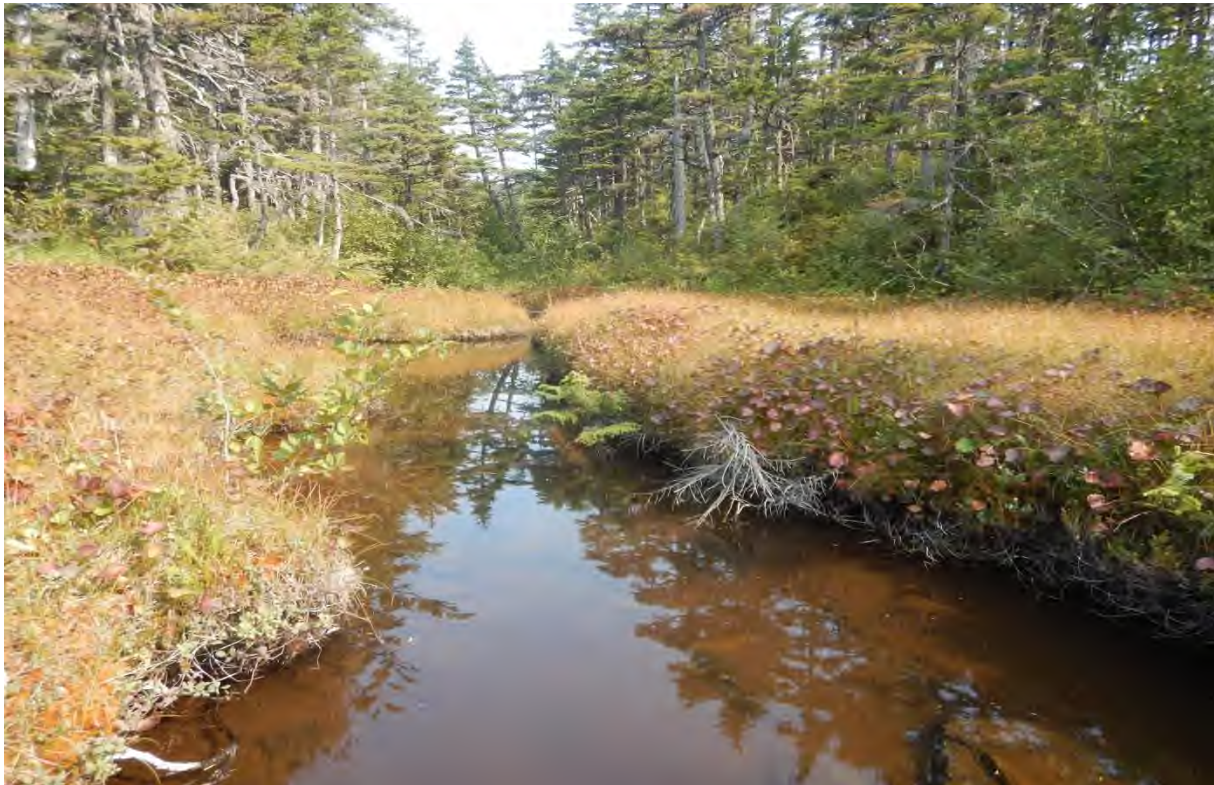
Figure 3. The second stream, view looking downstream.

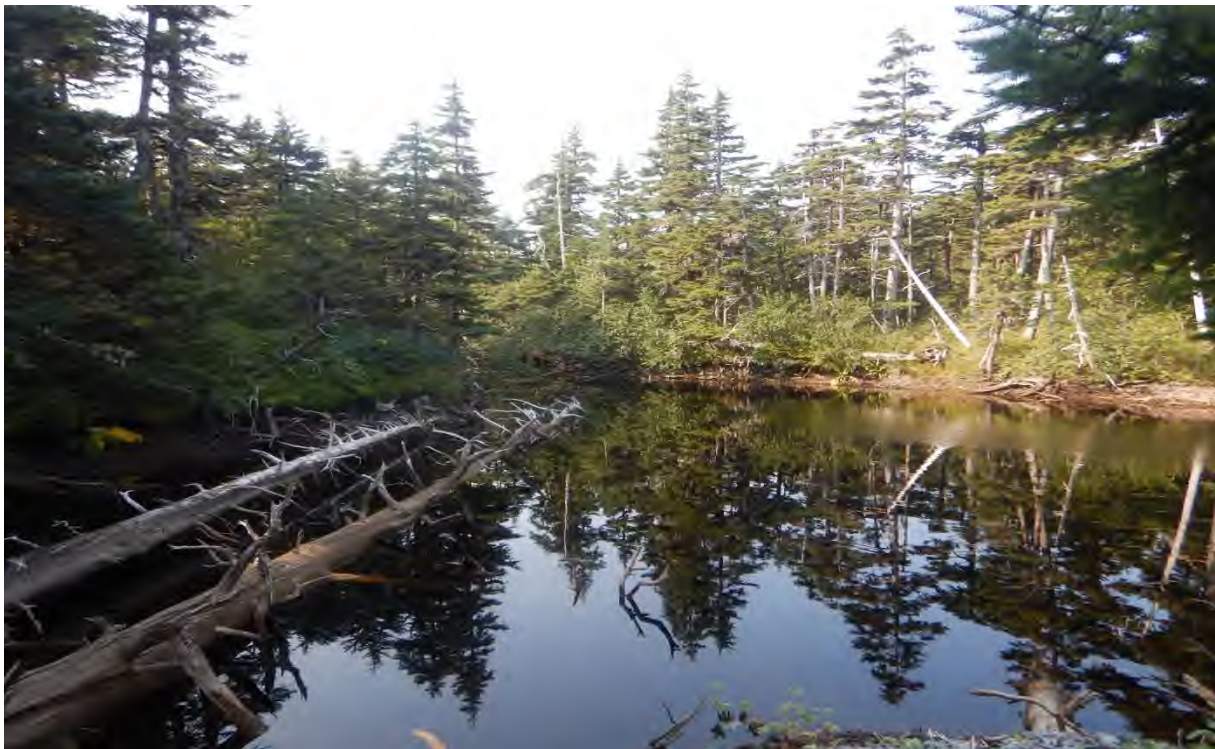
Figure 6. Pond located adjacent to tidewater.
