Storm Drain Modeling Data & CCTV Storm
Drain Condition Assessment Memorandum

Date: July 7, 2020
From: Joey Hegna, P.E. – CRW Engineering Group, LLC
Project: Lois Drive and 32nd Avenue Pathway – Benson Boulevard to Minnesota Drive
Project No: PM&E# 19-08 (CRW# 10145.00)
Subject: Storm Drain Condition Assessment (DRAFT)

Lois Drive and 32nd Avenue Pathway – Benson Boulevard to Minnesota Drive
Storm Drain Condition Assessment (DRAFT)

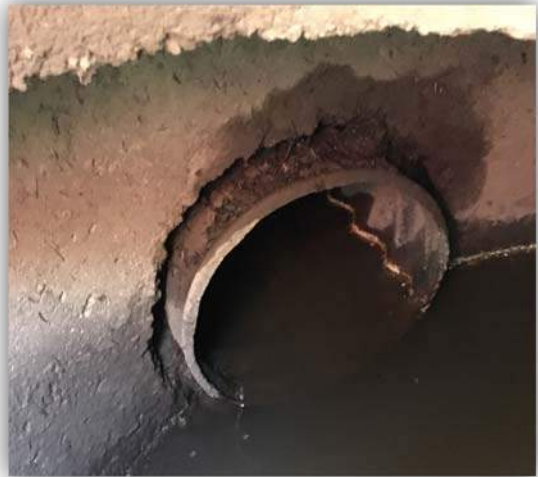
Photo 3 - Grout Loss at Pipe Penetration

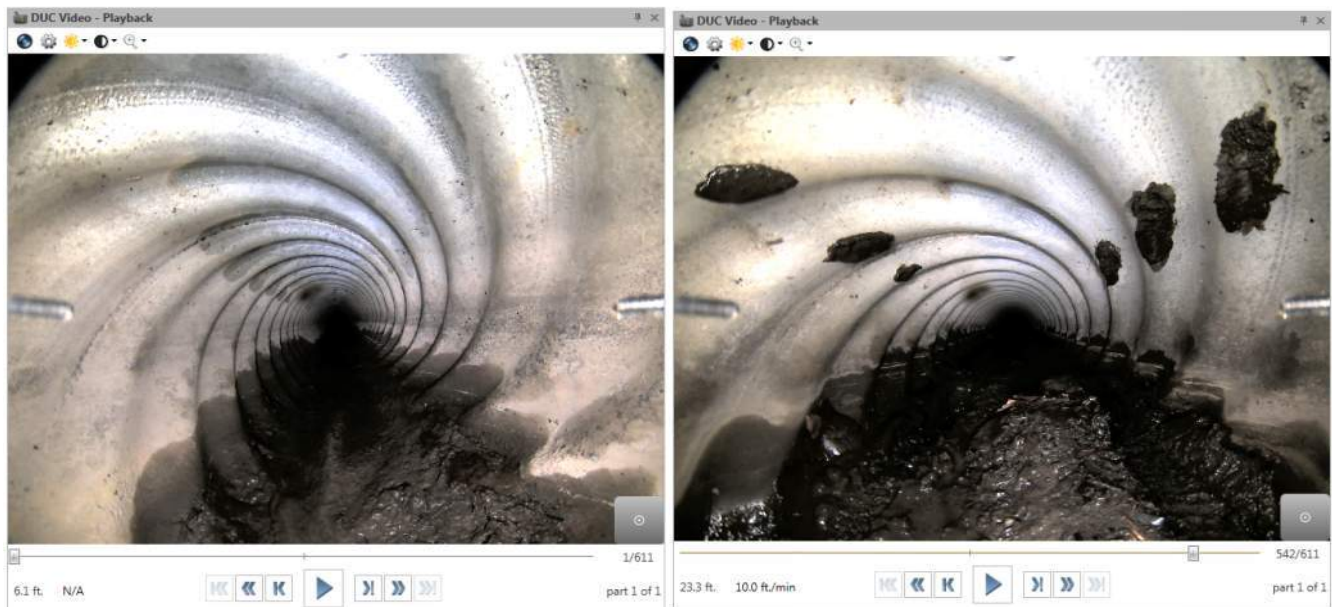
Miscellaneous/Defect Notes: Pipe appears to be in good condition, but leaf buildup is restricting flow. Looks like some root intrusion is possible along walls.

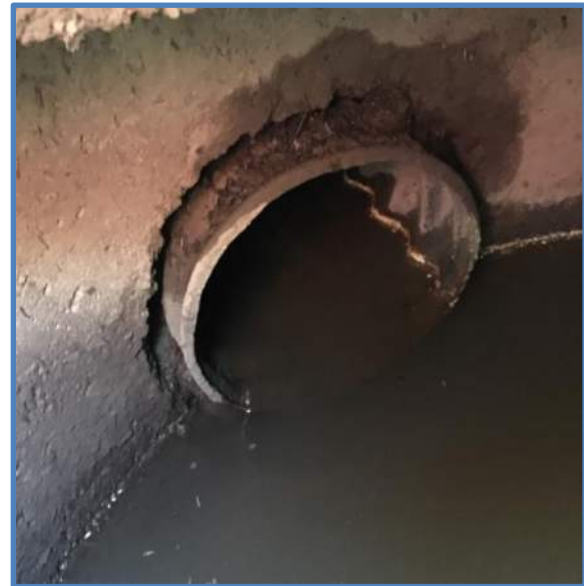
- Grout spalling at pipe penetration
- Non-standard inlet, 11.5" x 15", rectangular, frame depth 10"
- No grade rings, frame placed on reducing slab

Photo 4 - Outlet Pipe Penetration

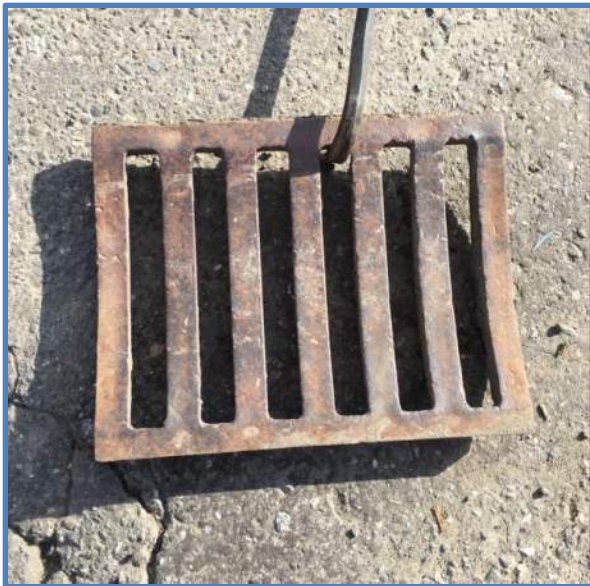
Photo 3 - Inlet

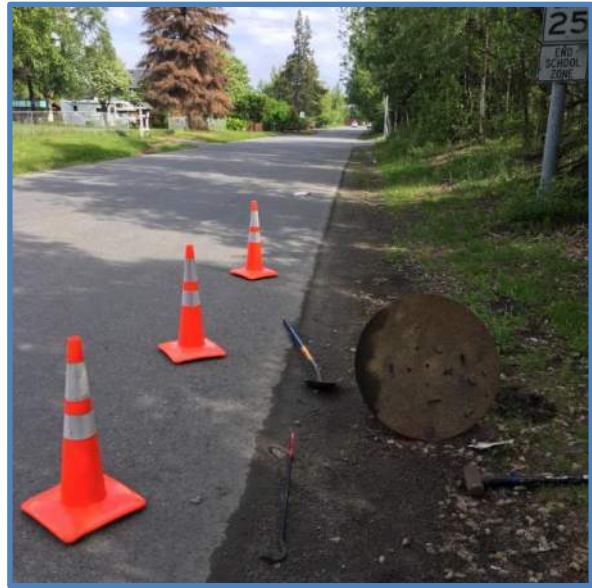
Photo 2 – Manhole Lid / Surrounding Area

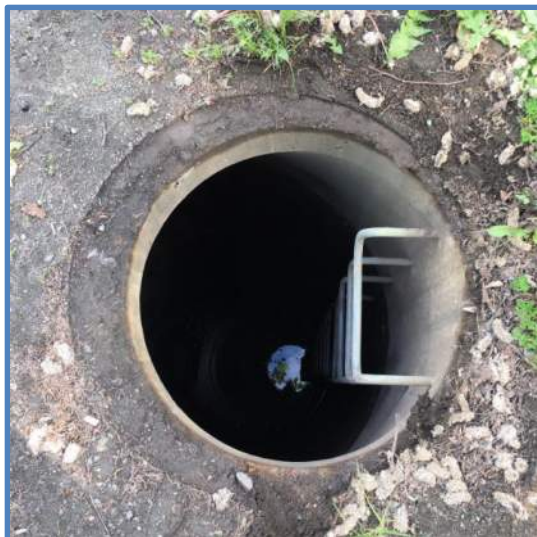
- Non-standard lid with 3 angle pieces welded onto lid
- 12 non-standard steel ladder rungs

Photo 4 – Manhole Cone & Ladder Rungs

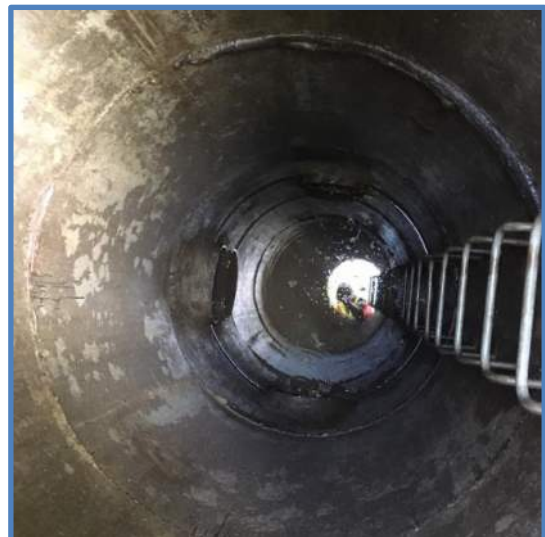
Photo 5 – Inlet & Outlet Pipe Penetrations

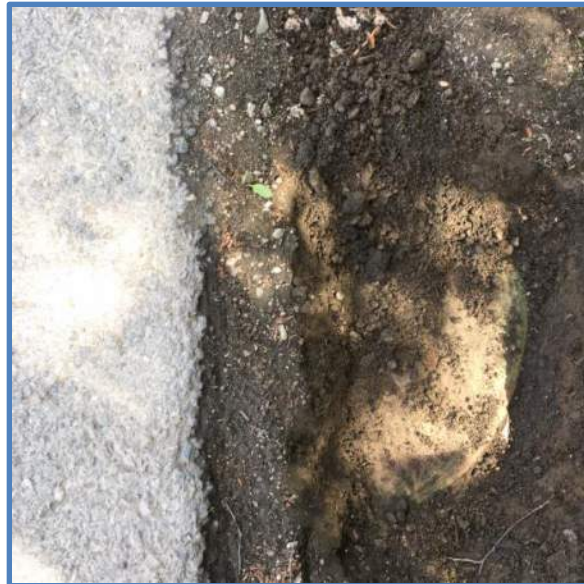
Photo 3 – Manhole Lid Under Pavement

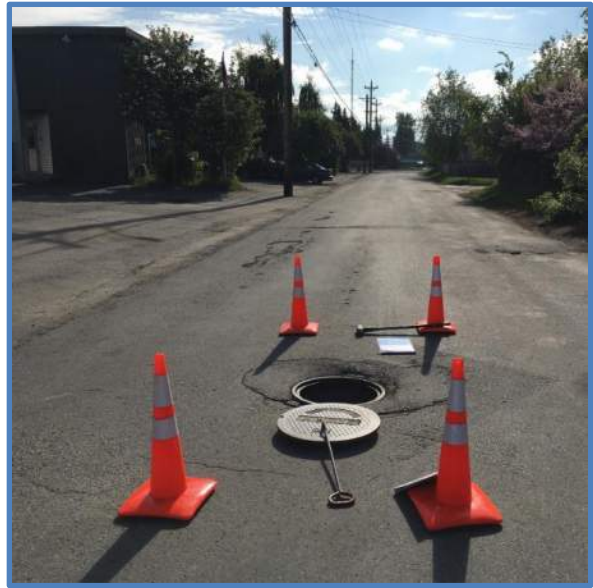
Photo 2 - Manhole / Surrounding Area

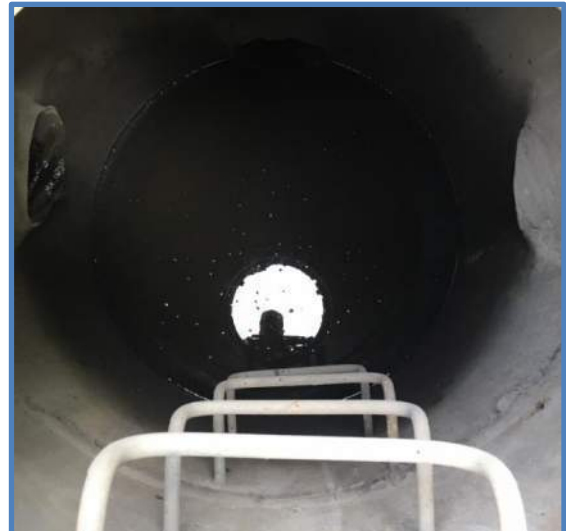
- 4 non-standard steel ladder rungs
- Buried MH cover in gravel
- Vertical cracking in grade ring
- Grade ring placement is offset from cone and frame

Photo 5 - Inlet & Outlet Pipe Penetrations & Ladder Rungs
